**Détection et quantification operando de  
l'endommagement dans les composants automobiles en  
composite polyamide/renfort continu soumis à la  
fatigue-pré et/ou post impact par les techniques  
ultrasonores avancées**

## **THÈSE**

Spécialité : **Mécanique et Matériaux**

# **Detection and quantification of damage in a polyamide-based composite submitted to the fatigue-pre and/or post-impact by advanced ultrasonic techniques**

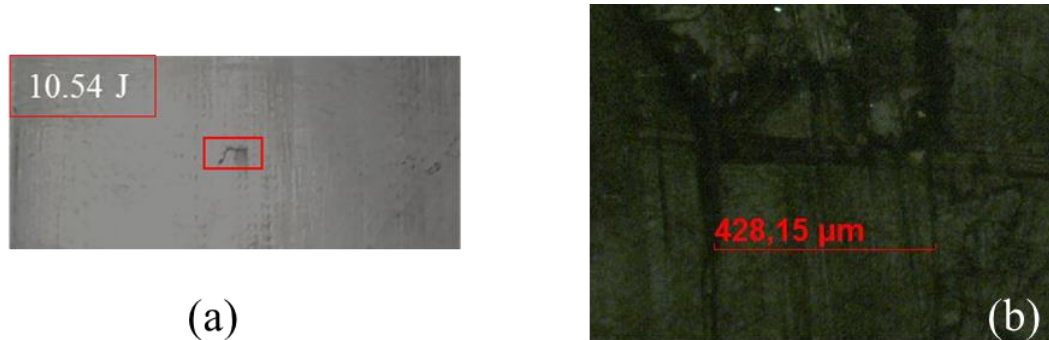
**Figure 35: Damage observed on the non-impacted surface (a) and a microscopic measurement of the crack (b) for the sample impacted at an energy level of 10.54 J.**

A visual inspection of the non-impacted side of the samples shows no visible damage on the sample impacted at 7.20 J. A first damage stage is observed on the sample impacted at 10.54 J. This damage consists in a small opening, barely visible to the naked eye. Due to the very small dimension of the damage, an observation using optical microscope is performed. **Figure 35** represents the obtained images of the small opening. Starting from 12.6 J as impact energy, cracks propagating longitudinally and transversely leading to fiber breakage are noticed. **Figure 36** shows the images of this damage on the non-impacted surface of each sample.

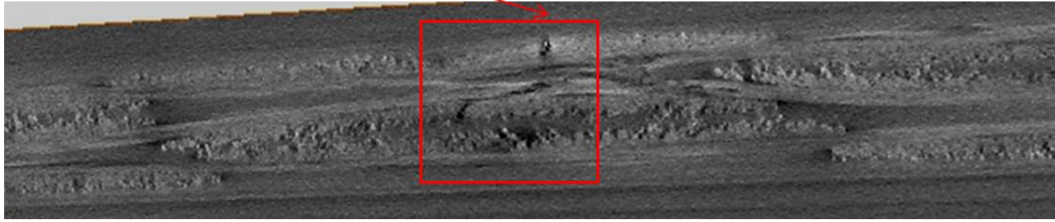
(a)

Cone shape damage indicating the fiber breakage path and pseudo-delamination

(b)

Crack network and fiber breaking
