Etude des mécanismes d'endommagement dans un polyamide 66 renforcé par des fibres de verre courtes, soumis à l'effet de vieillissement de l'éthylène glycol et de l'antigel

THÈSE

Damage mechanisms investigation in short glass-fiber reinforced polyamide 66 subjected to the aging effect of ethylene glycol and coolant

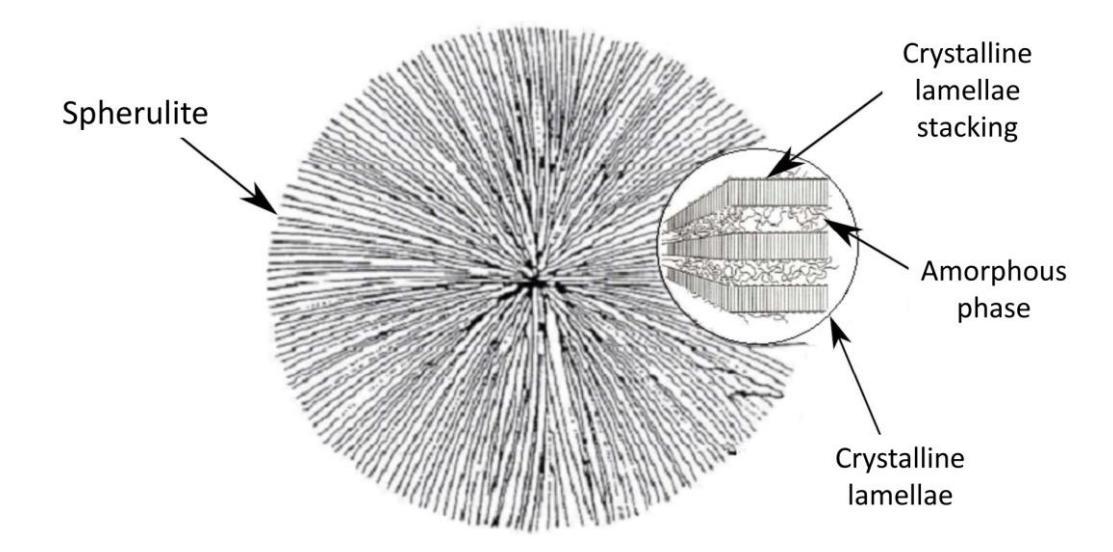
Figure 3. Schematic of a spherulite highlighting the semi-crystalline arrangement of polymer chains.

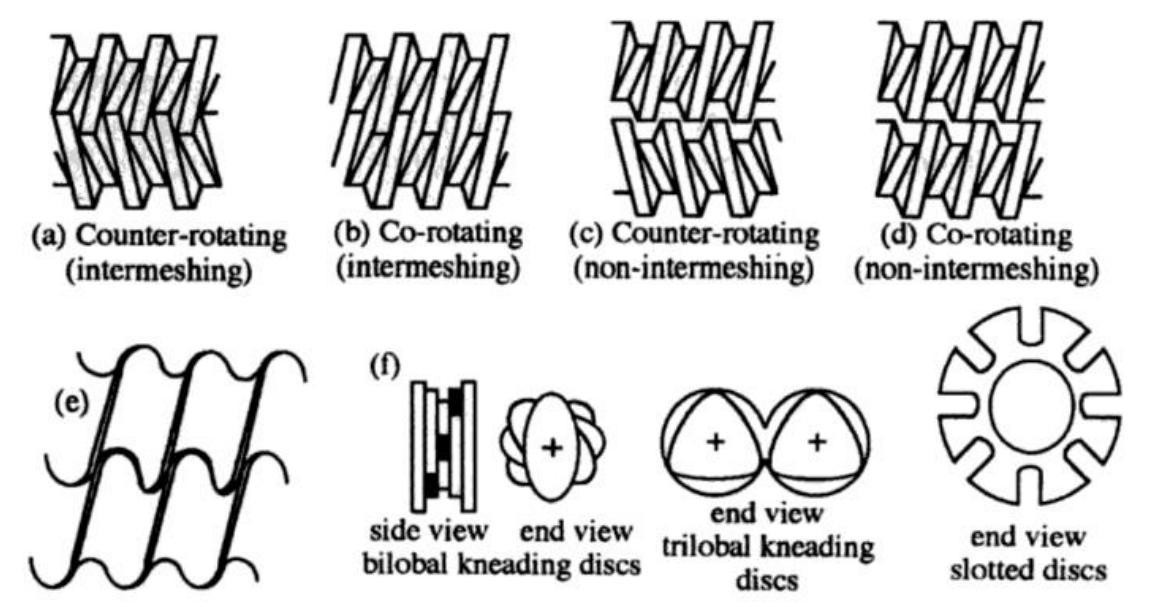
Figure 6. Schematics of the different types of extruders: (a) to (d) parallel screw designs, (e) twin screw profile with automatic rotation, (f) mixing discs [21].

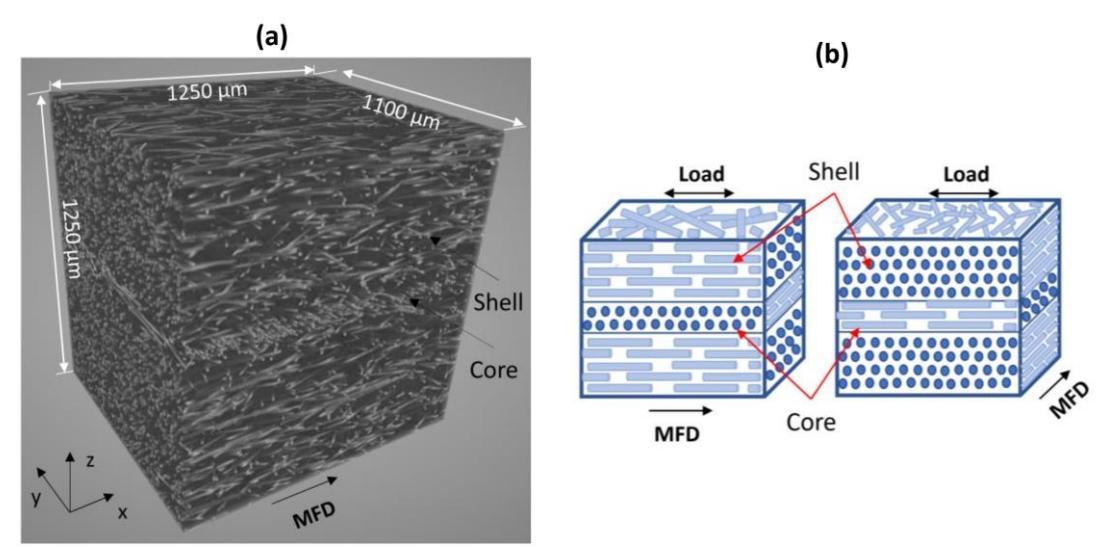
Figure 7. (a) Typical reconstructed volume for injected reinforced polyamide with transversally-oriented fibers using X-Ray microtomography with voxel size of 0.55 μ m, in which the shell-core microstructure is clearly observed. (b) Schematic diagram highlighting the fiber orientation in the shell-core microstructure with regard to the loading direction.
The shell layer is characterized by a fiber orientation similar to the MFD, representing around 90 % of the sample's thickness [6], while the fibers in the core layer are oriented transversally to the MFD, representing 5 % of the sample's thickness. In addition, the remaining 5 % form a thin layer at the surface with random fiber orientation, due to the contact between the mold wall and the melted polymer. This particular microstructure with three layers composition is commonly observed in injection molded short fiber composites. It results in a microstructure-driven thermomechanical response [8] and undeniably affects the damage mechanisms initiation and accumulation.

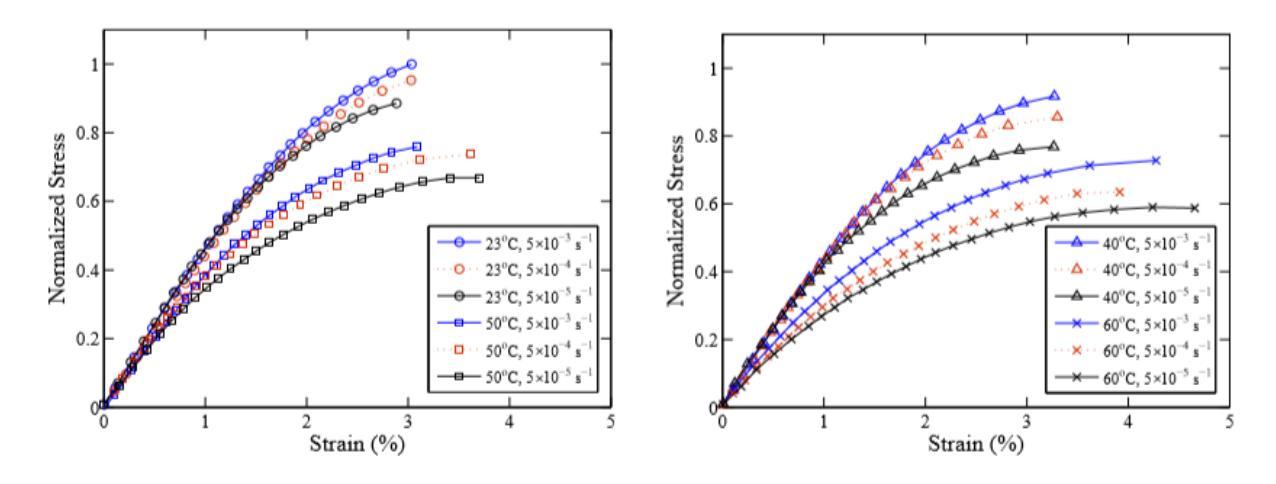
Figure 8. Temperature and strain rate effect on the mechanical response of PA66GF30 at RH 0 % from monotonic tensile tests [9].

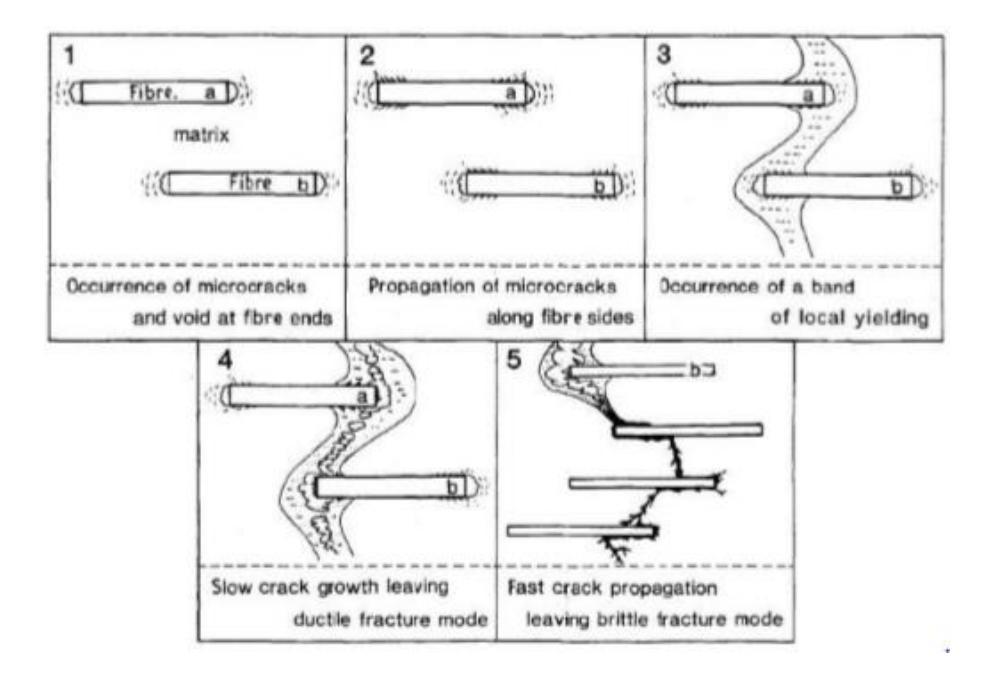
Figure 16. Damage chronology of a glass fiber reinforced polyamide suggested by Sato et al. [59].

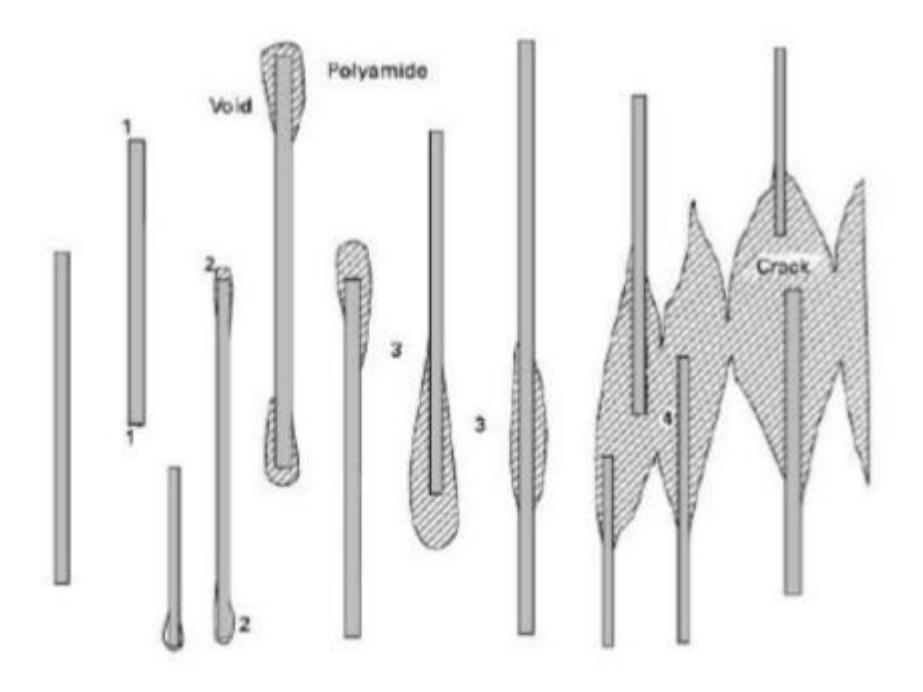
Figure 20. Local damage mechanisms under fatigue loading on PA66/GF30 [60], [61].

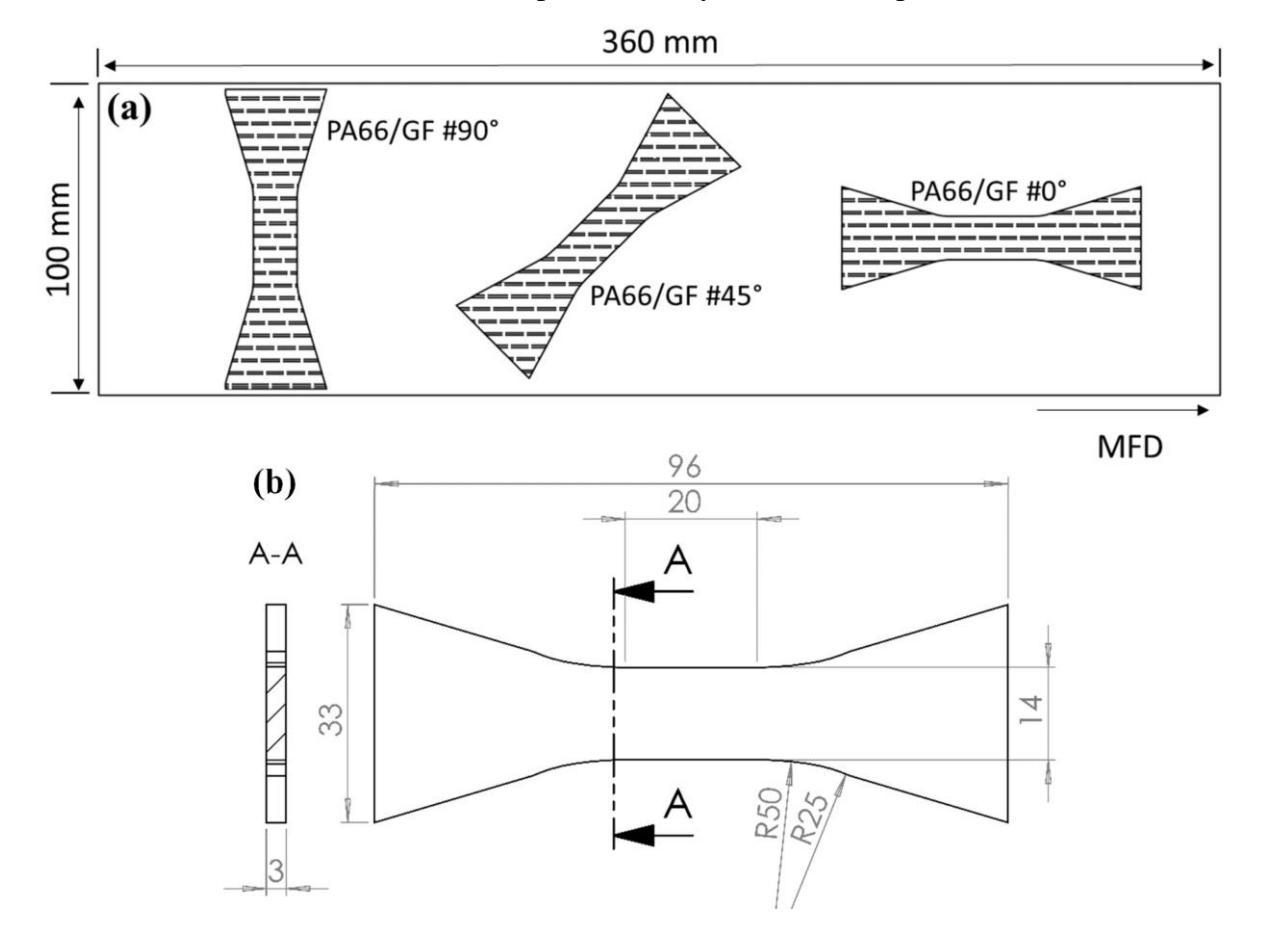
Figure 26. Schematics of dog bone samples used for the study. (a) Samples arrangement in the mold-injected plate displaying the fiber orientations considered. (b) Sample geometry with dimensions in mm.

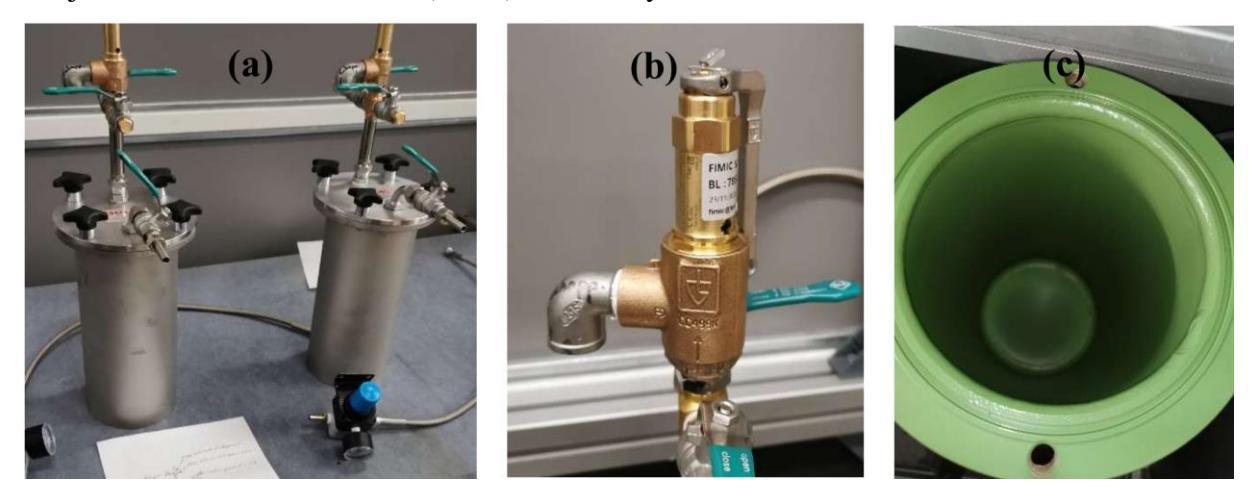
Figure 27. High-pressure tanks used for glycol and cooling aging. (a) High-pressure tanks and their components as received. (b) High pressure valve set at 7 bars. (c) The inside of high-pressure tanks after Teflon coating application.

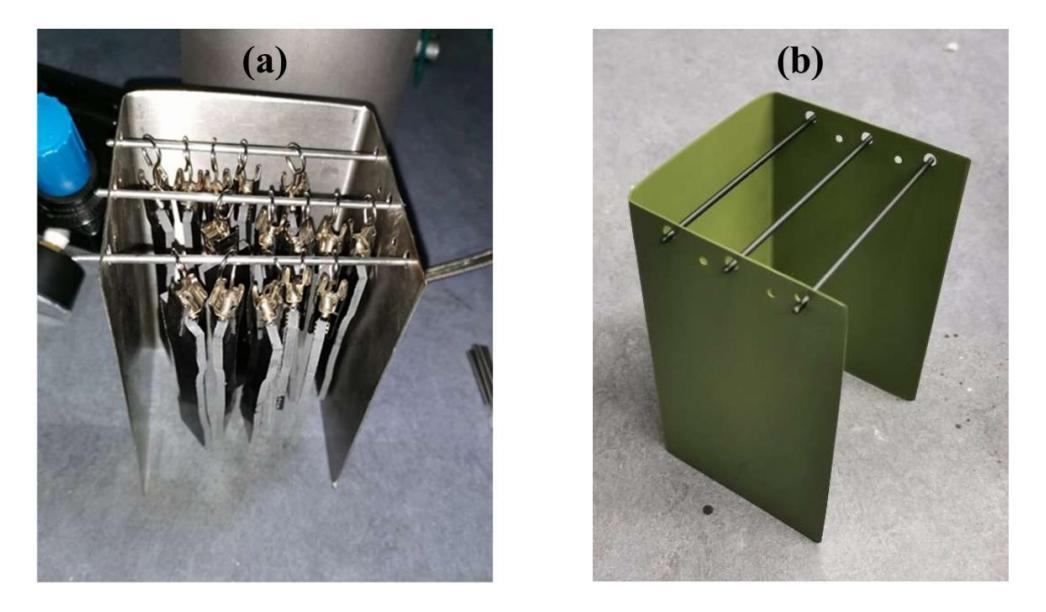
Figure 30. Designed and fabricated samples' holder allowing the samples to be floating during the aging procedure. (a) Initial state of the samples' holder displaying how the samples are floating. (b) The samples' holder after applying Teflon coating.

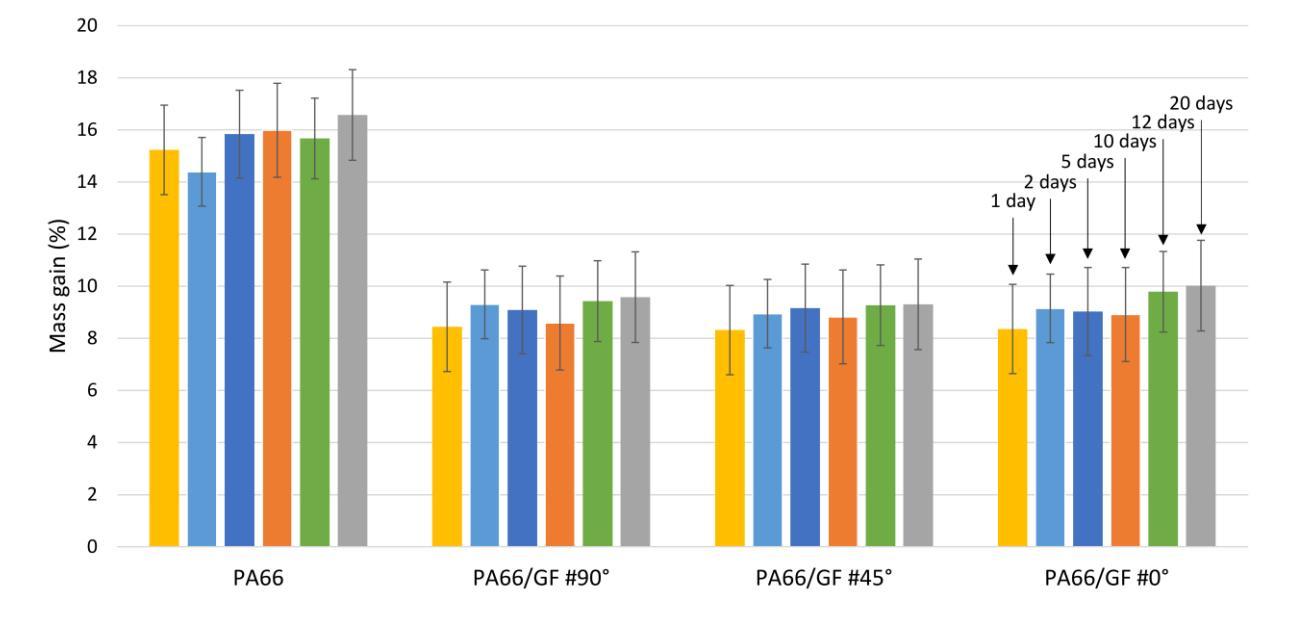
Figure 33. Mass variation of samples aged in coolant at different aging durations for both the unreinforced PA66 (matrix) and its short glass fiber reinforced composites (PA66/GF). Comparison with the initial configurations before aging. One can easily notice that, basically the PA66 polymer exhibits a larger mass gain than its reinforced composites whatever the microstructure and aging duration.

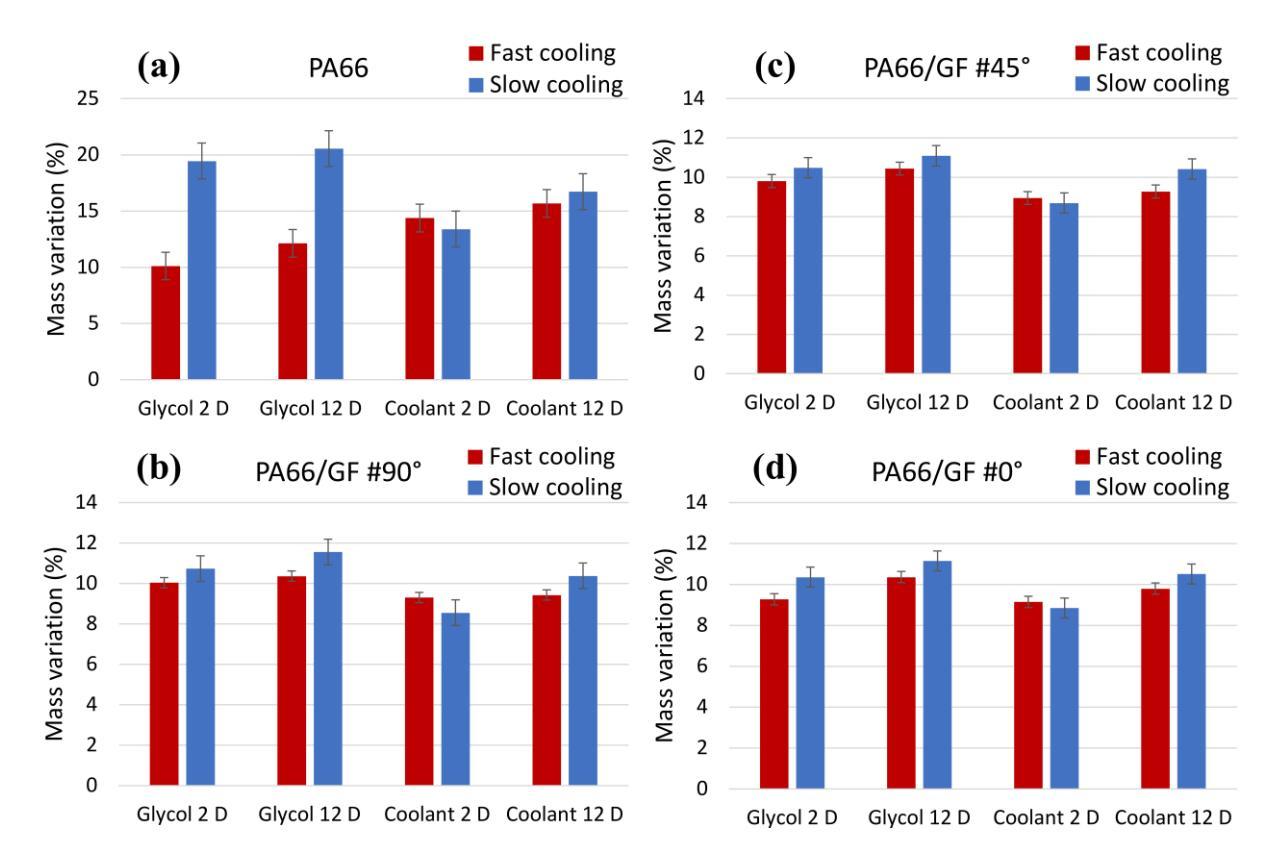
Figure 34. Mass variation of samples aged for 2 days and 12 days in ethylene glycol and coolant, comparing fast cooling and slow cooling method. (a) Unreinforced PA66. (b) PA66/GF at 90° fiber orientation. (c) PA66/GF at 45° fiber orientation. (d) PA66/GF at 0° fiber orientation.

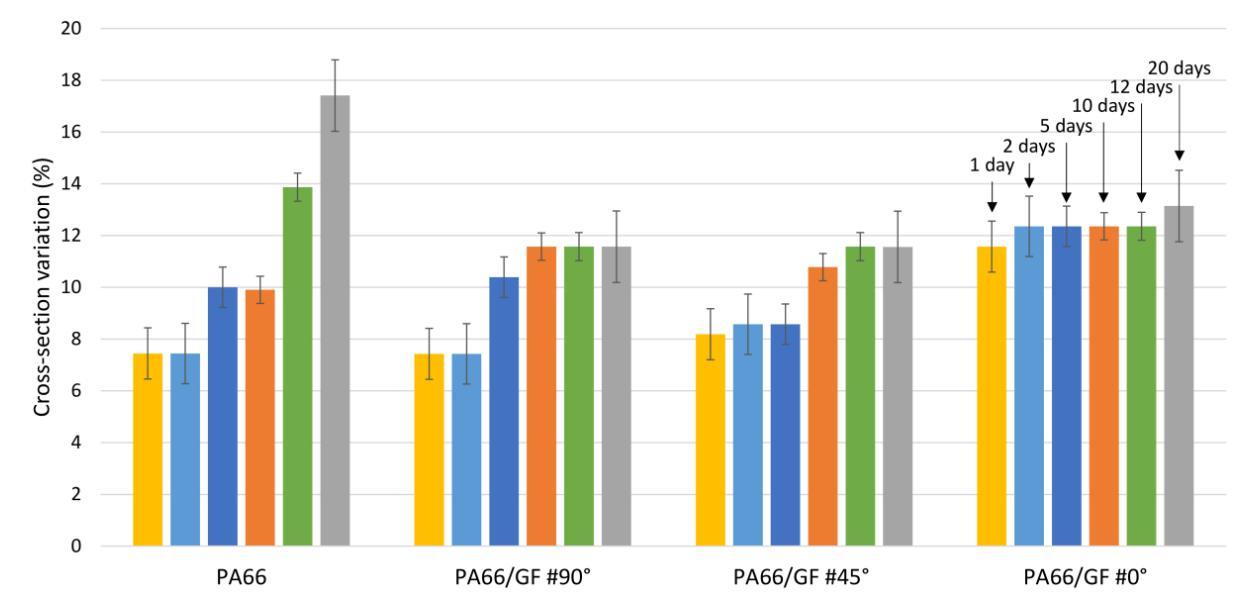
Figure 35. Cross-section variation of samples aged in ethylene glycol at different aging durations for both the unreinforced PA66 (matrix) and its reinforced composite. Comparison with the initial configurations before aging. The PA66 polymer exhibits a larger cross-section increase than its reinforced composites whatever the microstructure above 12 days aging.

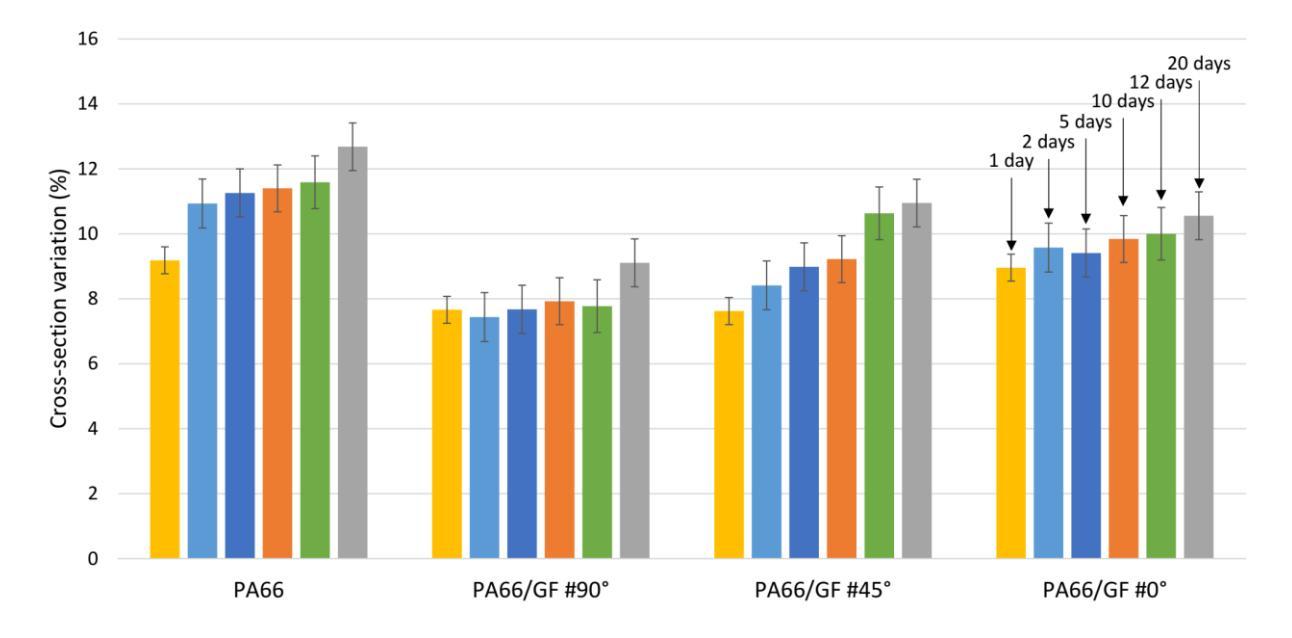
Figure 36. Cross-section variation of samples aged in coolant at different aging durations for both the unreinforced PA66 (matrix) and its reinforced composite. Comparison with the initial configurations before aging.

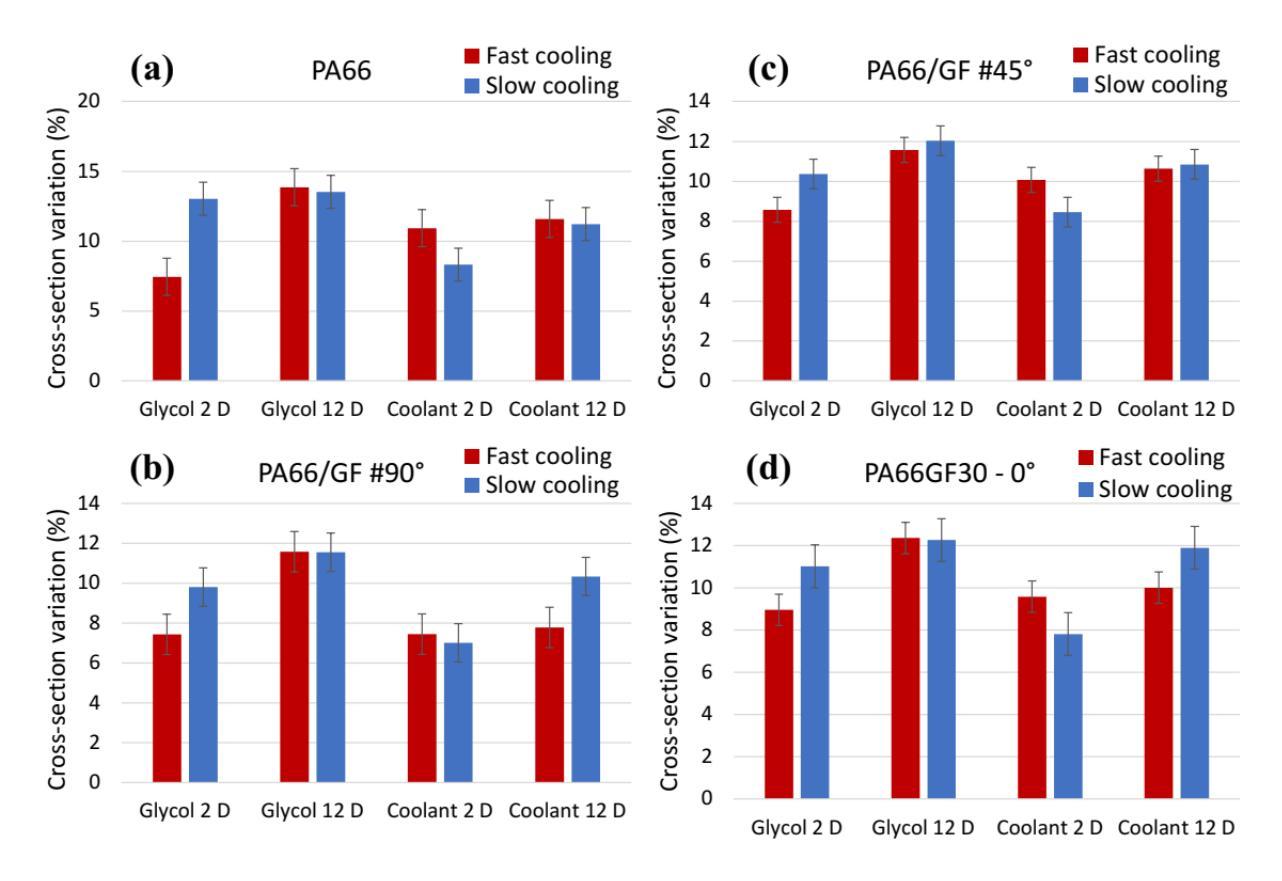
Figure 37. Cross-section variation of samples aged for 2 days and 12 days in ethylene glycol and coolant, comparing fast cooling and slow cooling method. (a) Unreinforced PA66. (b) PA66/GF at 90° fiber orientation. (c) PA66/GF at 45° fiber orientation. (d) PA66/GF at 0° fiber orientation.

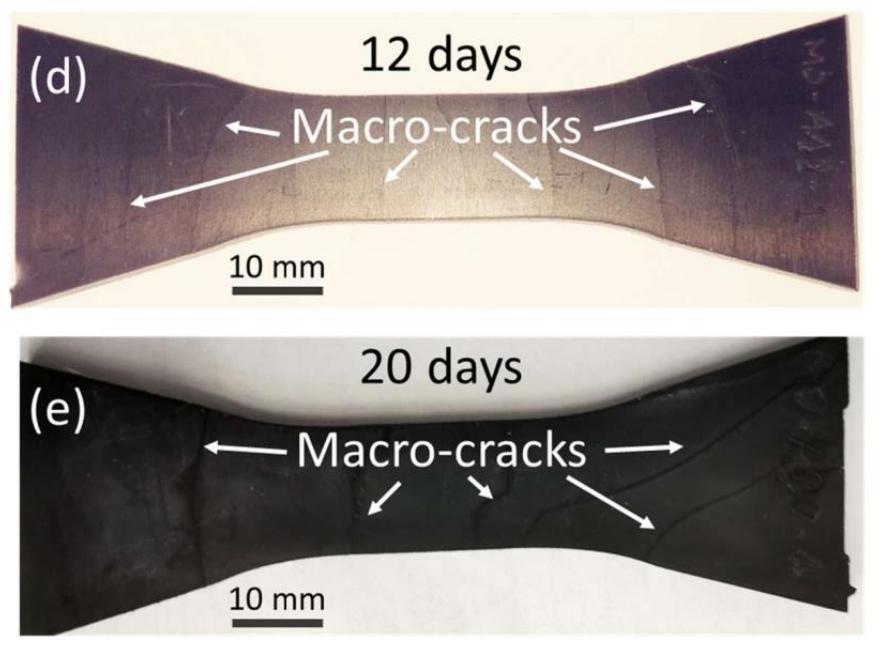
Figure 38. Overview of the surface state of PA66 samples after aging with respect to the case (a). Unaged. (b). Aged in glycol for 12 days. (c). Aged in glycol for 20 days. (d) Aged in coolant for 12 days. (e) Aged in coolant for 20 days. The results highlight the strong effect of glycol and coolant aging in which a macro-crack network appear on the surface of the aged samples.

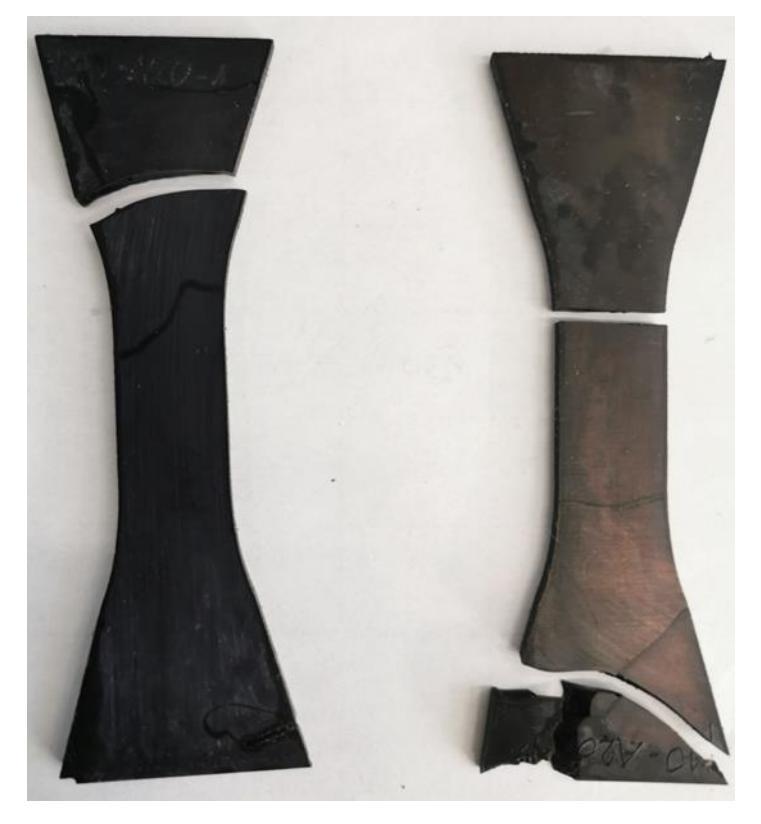
Figure 39. Broken PA66 samples undergoing coolant aging for 20 days, confirming that the coolant aging is more severe with deeper macrocracks than the glycol aging.

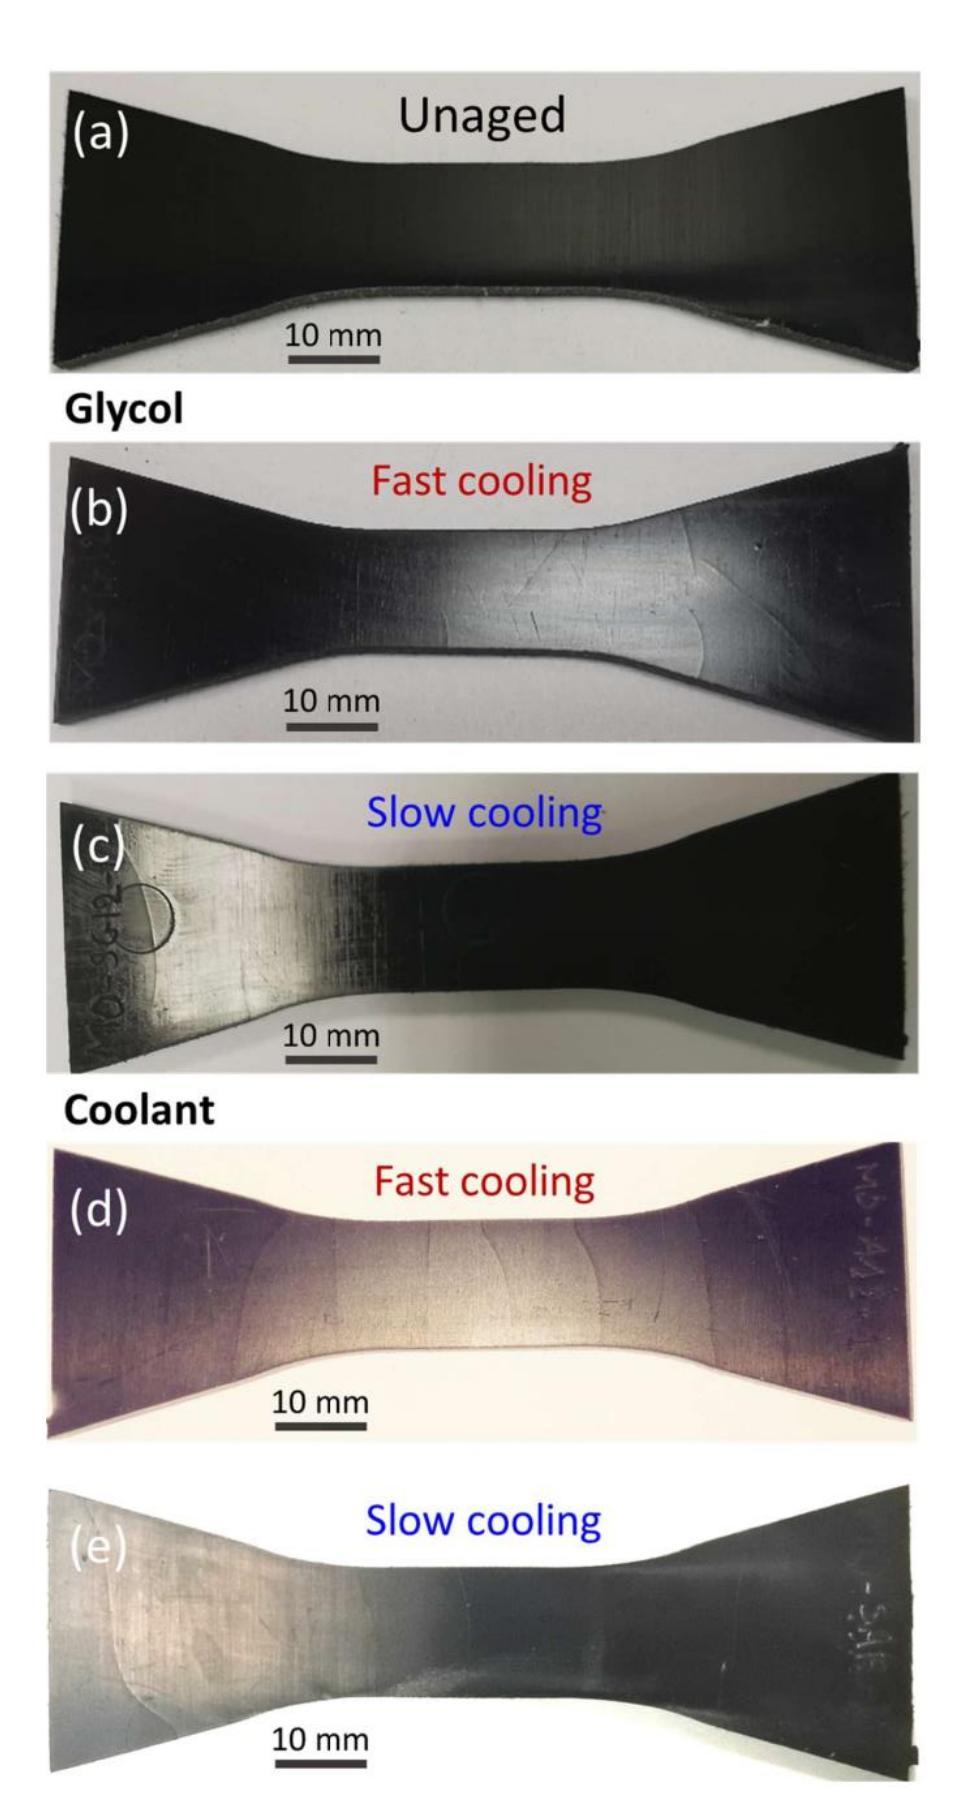
Figure 40. Comparison of the cooling effect on the surface state of PA66 samples after aging with respect to the case (a). Unaged. (b). Fast cooling after glycol aging for 12 days. (c). Slow cooling after glycol aging for 12 days. (d) Fast cooling after coolant aging for 12 days. (e) Slow cooling after coolant aging for 12 days.
3. Chapter conclusion

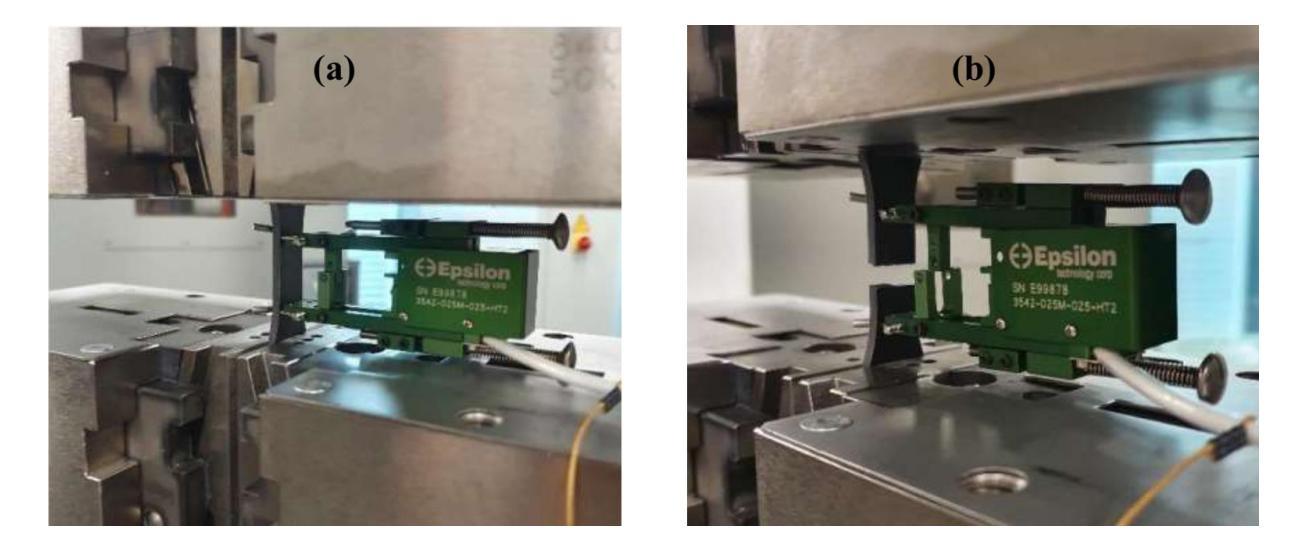
Figure 42. Display of the monotonic tensile testing setup the Zwick/Roell Z050 machine. (a) Image of the sample mounted with the extensioneter prior to loading. (b) Image of the ruptured samples after mechanical loading where the rupture area is located between the extensioneters' blades.

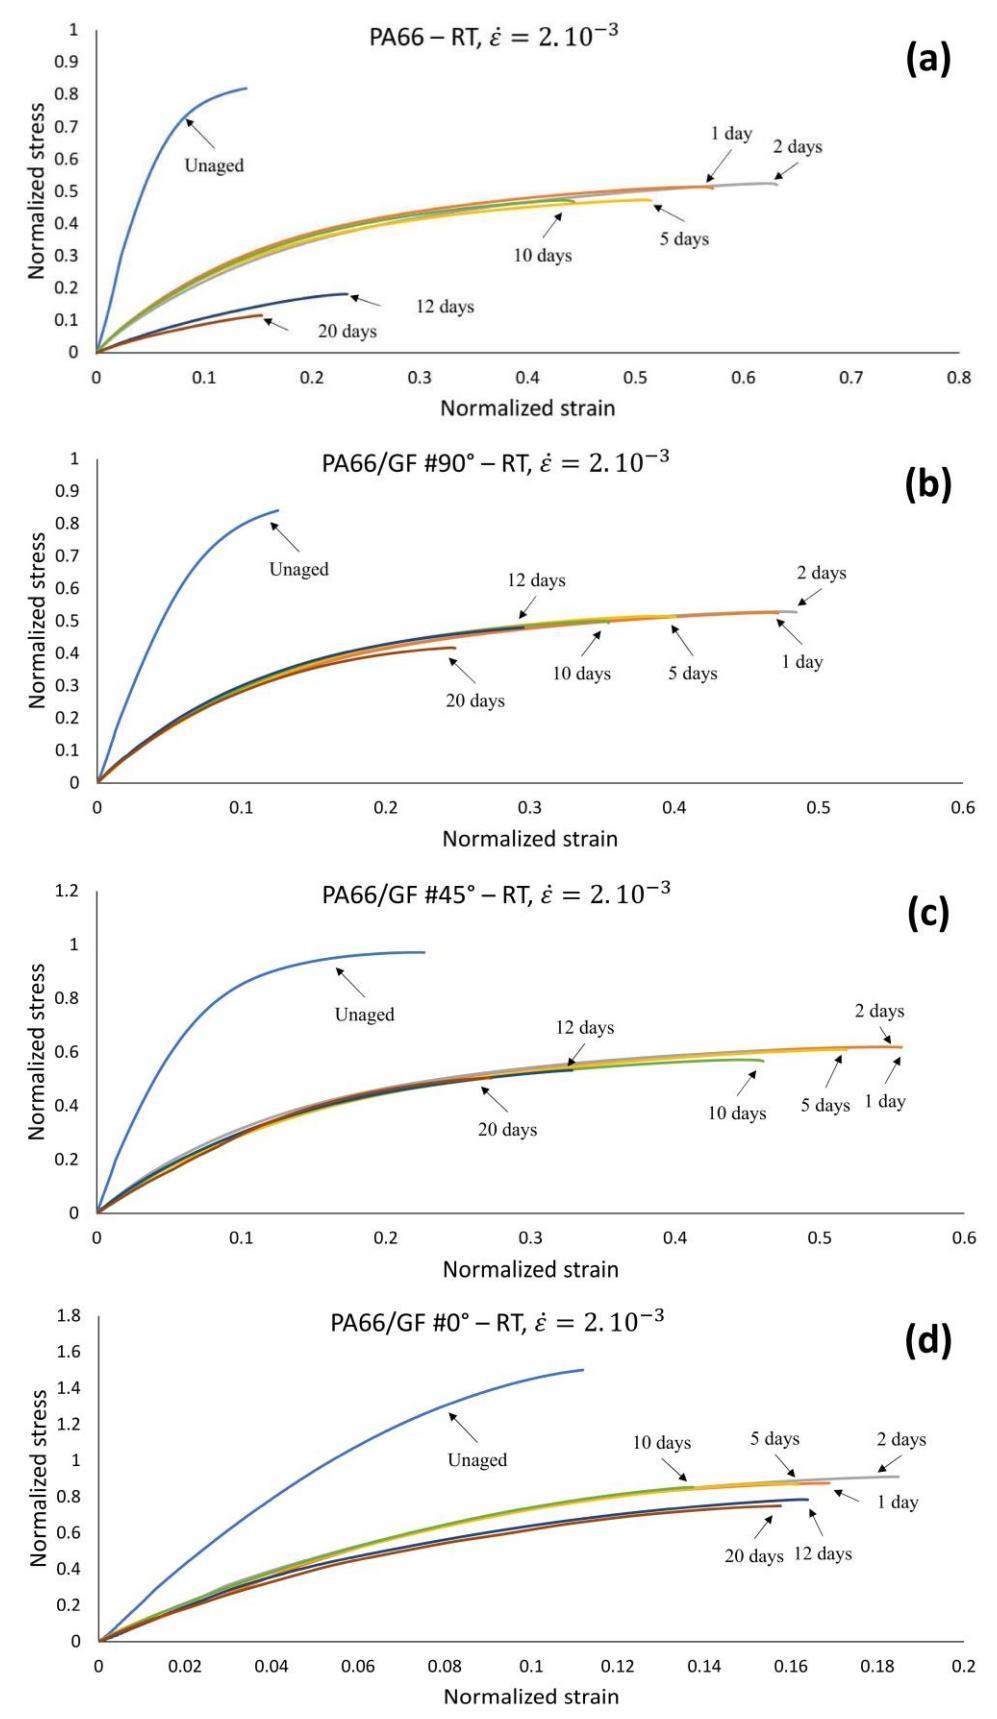
Figure 43. Normalized monotonic tensile responses for unaged and aged samples at 1 day, 2 days, 5 days, 10 days, 12 days and 20 days aging in glycol. These tests have been performed at a displacement rate of 1 mm/s, corresponding to a strain rate of 2.10^{-3} s⁻¹. (a) PA66, (b) PA66/GF #90°, (c) PA66/GF #45°, (d) PA66/GF #0°.

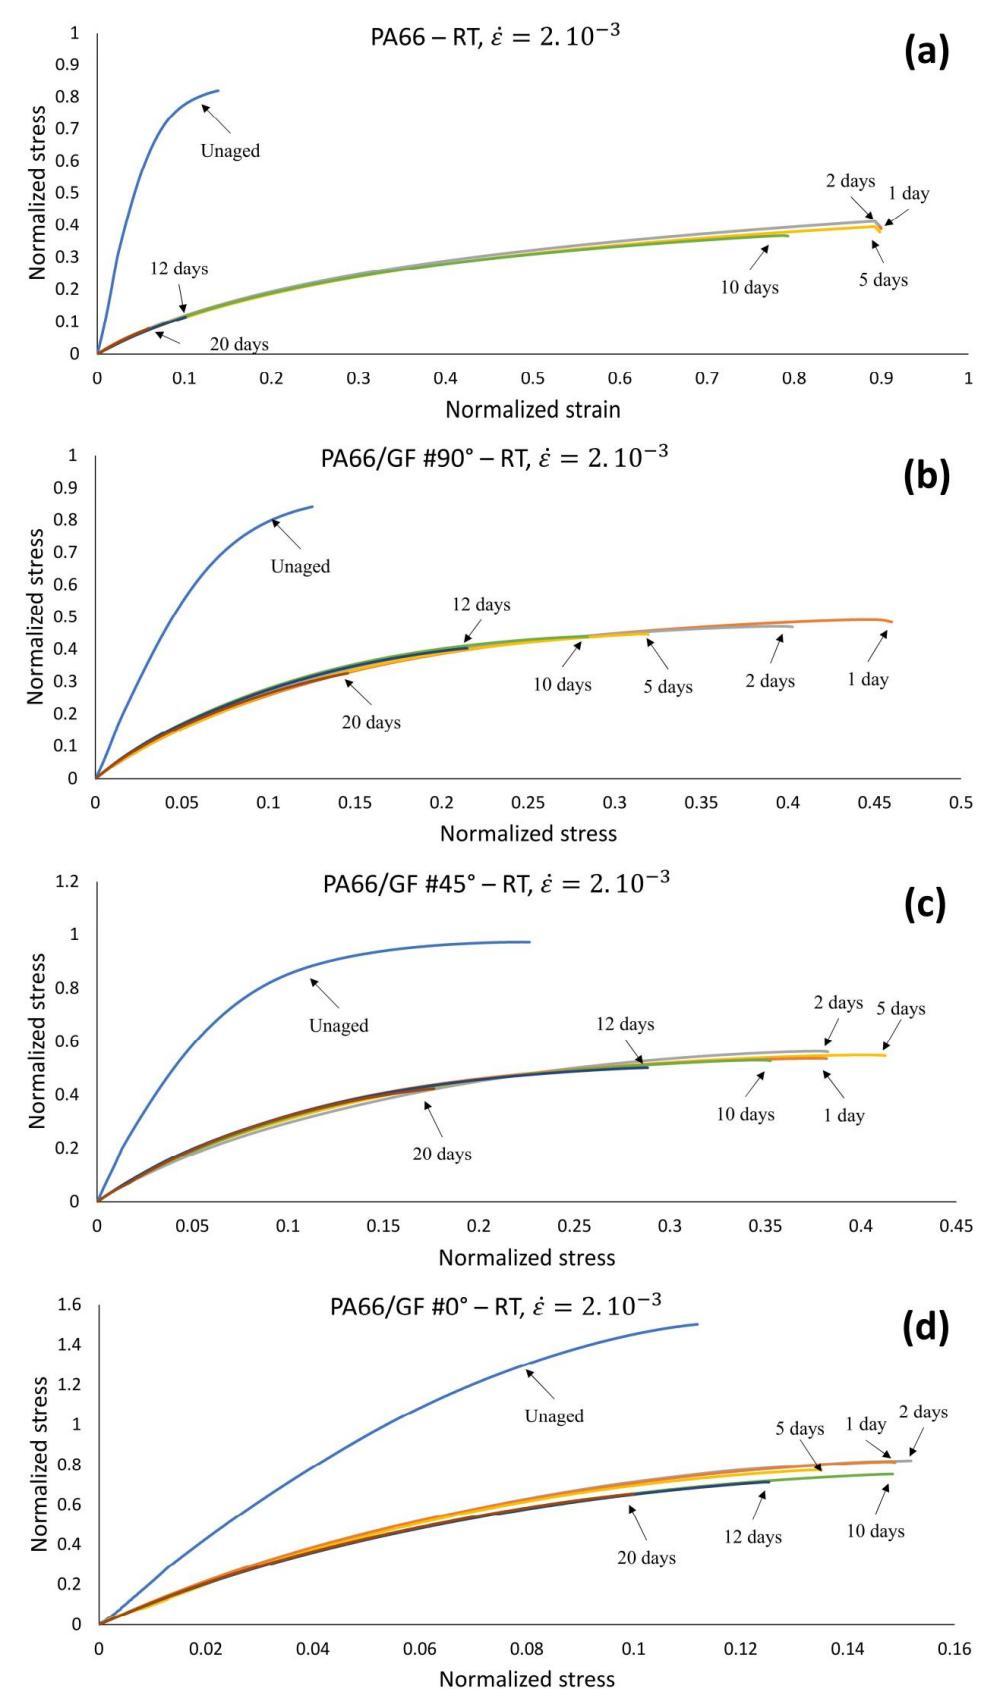
Figure 44. Normalized monotonic tensile responses for unaged and aged samples at 1 day, 2 days, 5 days, 10 days, 12 days and 20 days aging in coolant. These tests have been performed at a displacement rate of 1 mm/s, corresponding to a strain rate of 2.10⁻³ s⁻¹. (a) PA66, (b) PA66/GF #90°, (c) PA66/GF #45°, (d) PA66/GF #0°.

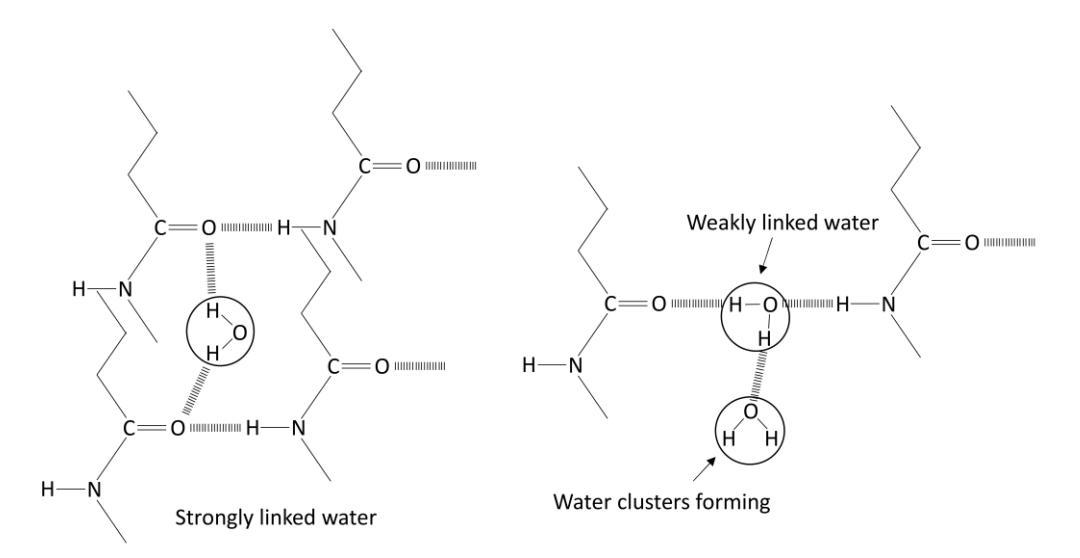
Figure 45. Types of water interacting with the polyamide, as illustrated in [69]. It is claimed that the water contained in the polyamide is linked in 3 different ways; Strongly linked water: forming two hydrogen bonds with two polyamide molecular chains, weakly linked water: forming one hydrogen bond with two polyamide molecular chains, and water clusters: water molecules forming chains that evolve into clusters.

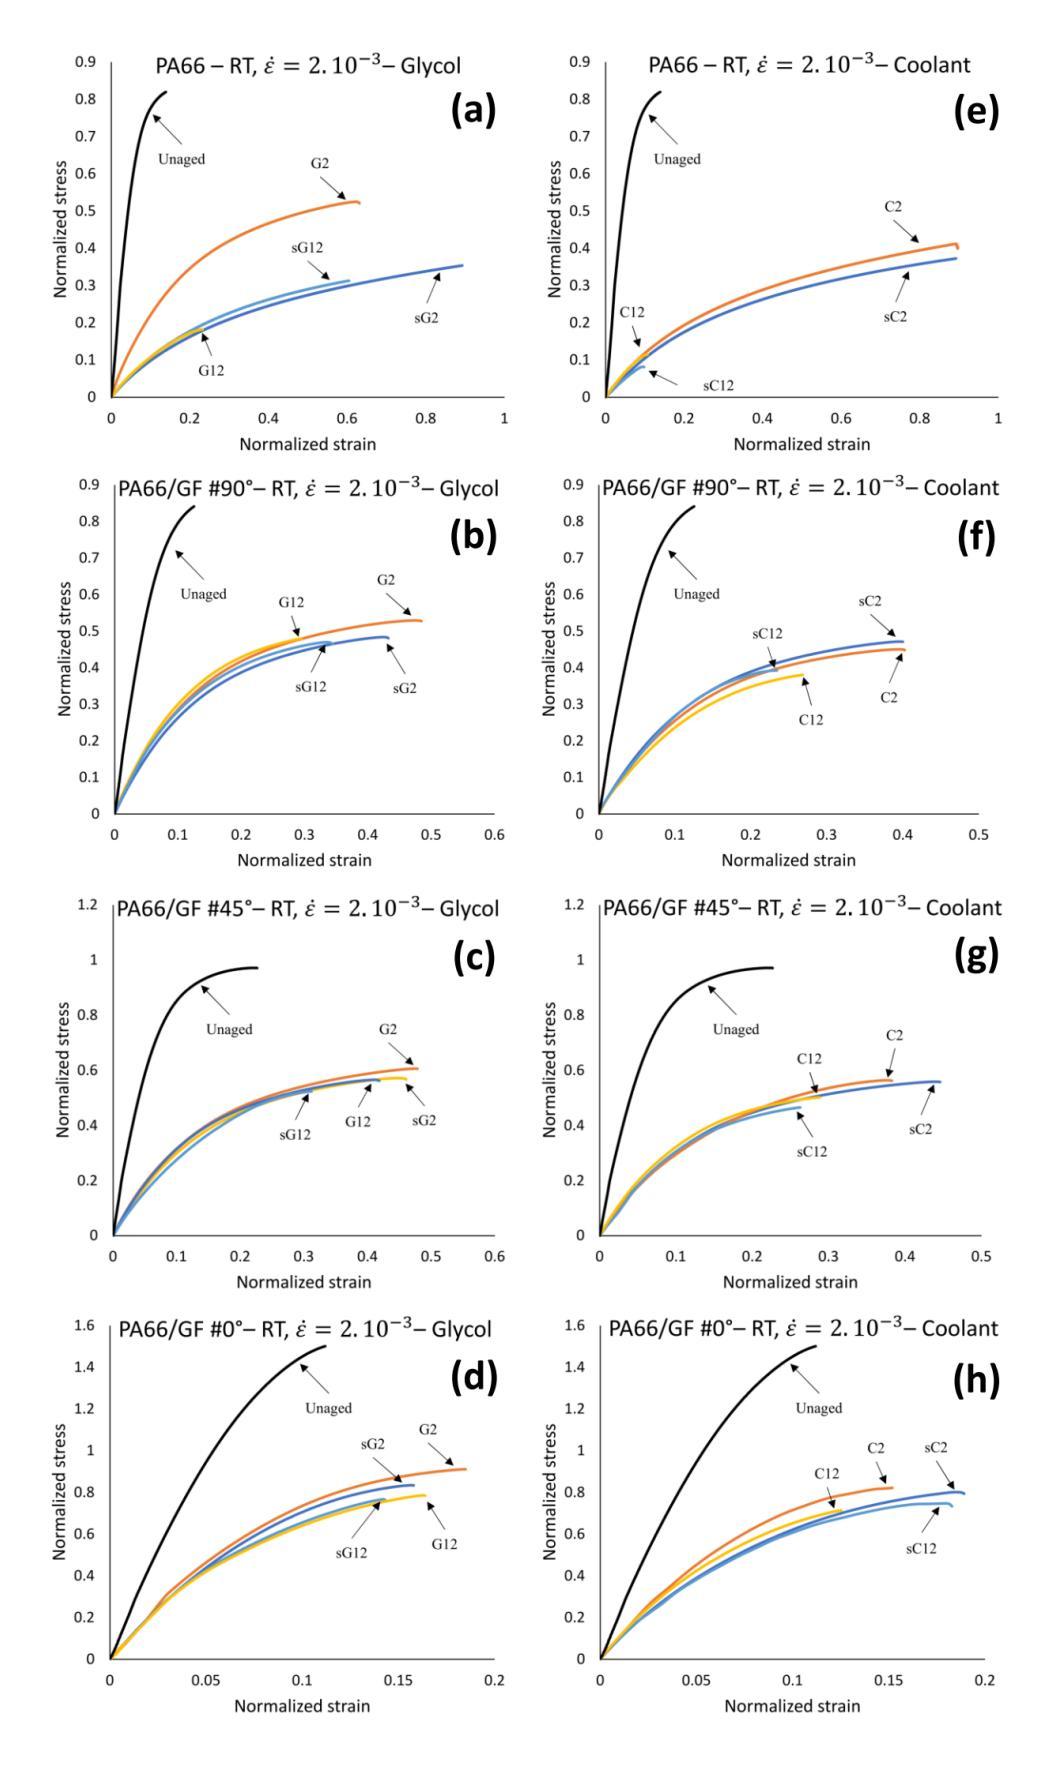
Figure 46. Normalized monotonic tensile test responses for unaged (dry) and aged samples at 2 days and 12 days aging in glycol and coolant using both fast-cooling and slow-cooling methods. These tests have been performed at a displacement rate of 1 mm/s, corresponding to a strain rate of 2.10⁻³ s⁻¹

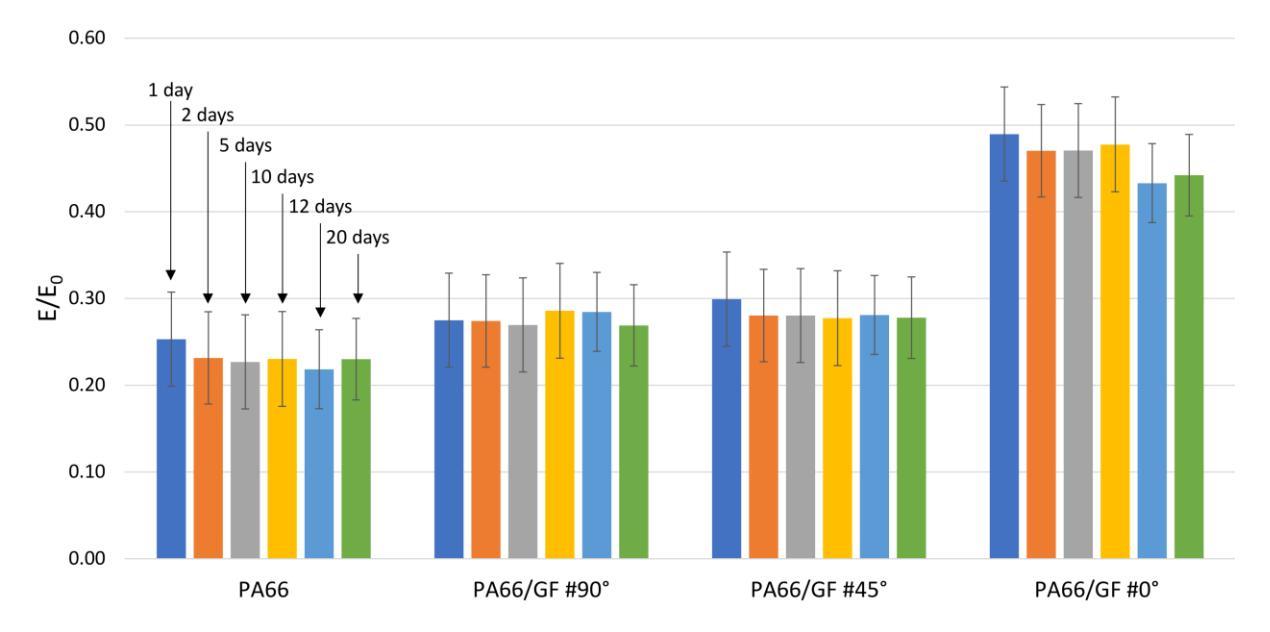
Figure 48. Stiffness degradation for unreinforced and short glass fiber reinforced PA66 samples aged in coolant for 1 day, 2 days, 5 days, 10 days, 12 days, and 20 days.
