Etude des mécanismes d'endommagement dans un polyamide 66 renforcé par des fibres de verre courtes, soumis à l'effet de vieillissement de l'éthylène glycol et de l'antigel

THÈSE

Damage mechanisms investigation in short glass-fiber reinforced polyamide 66 subjected to the aging effect of ethylene glycol and coolant

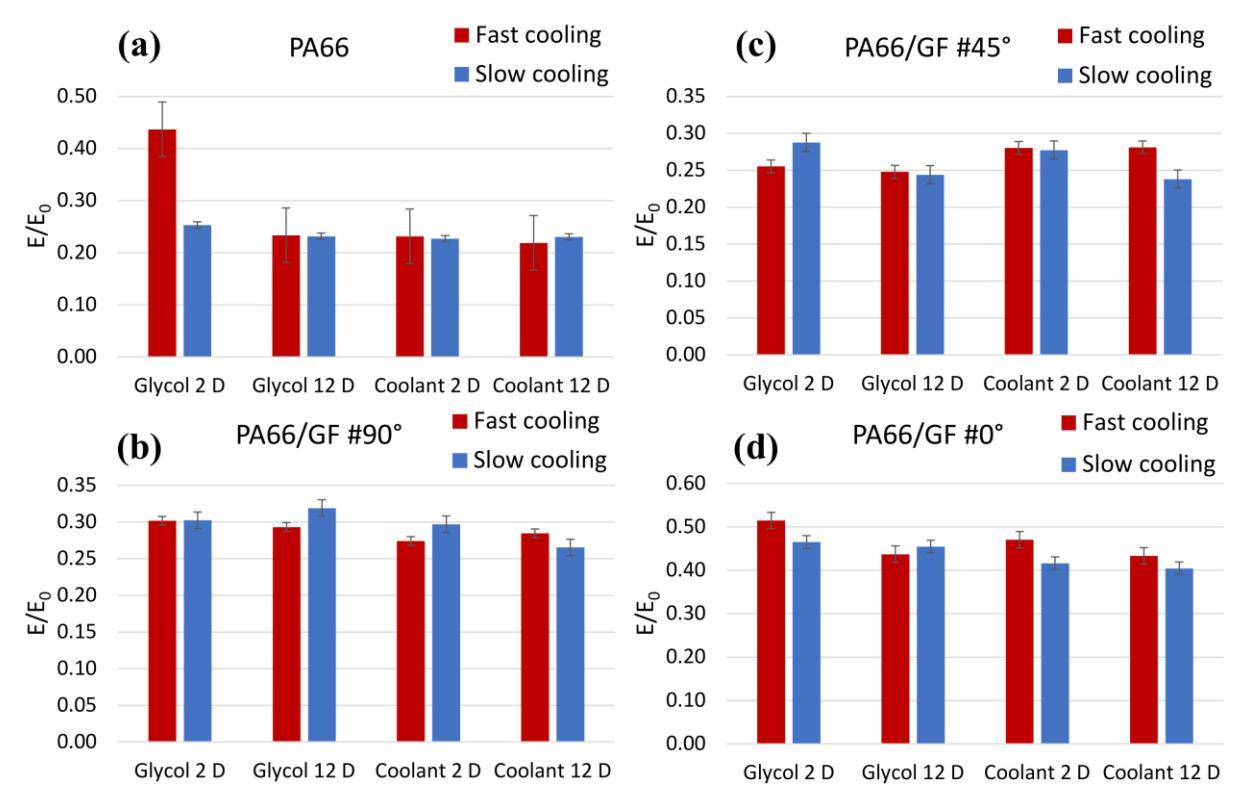
Figure 49. Stiffness degradation for unreinforced and short glass fiber reinforced PA66 samples aged in glycol and coolant for 2 days and 12 days using both fast-cooling and slow-cooling methods.

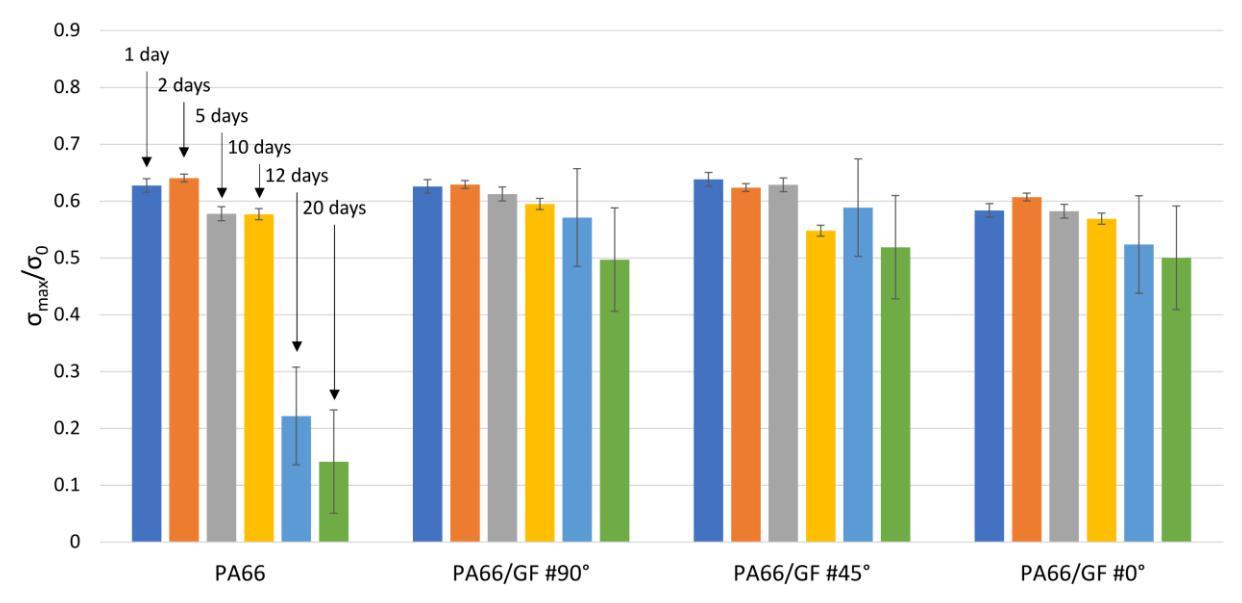
Figure 50. Evolution of the ultimate strength of unreinforced and short glass fiber reinforced PA66 samples aged in glycol for 1 day, 2 days, 5 days, 10 days, 12 days, and 20 days.

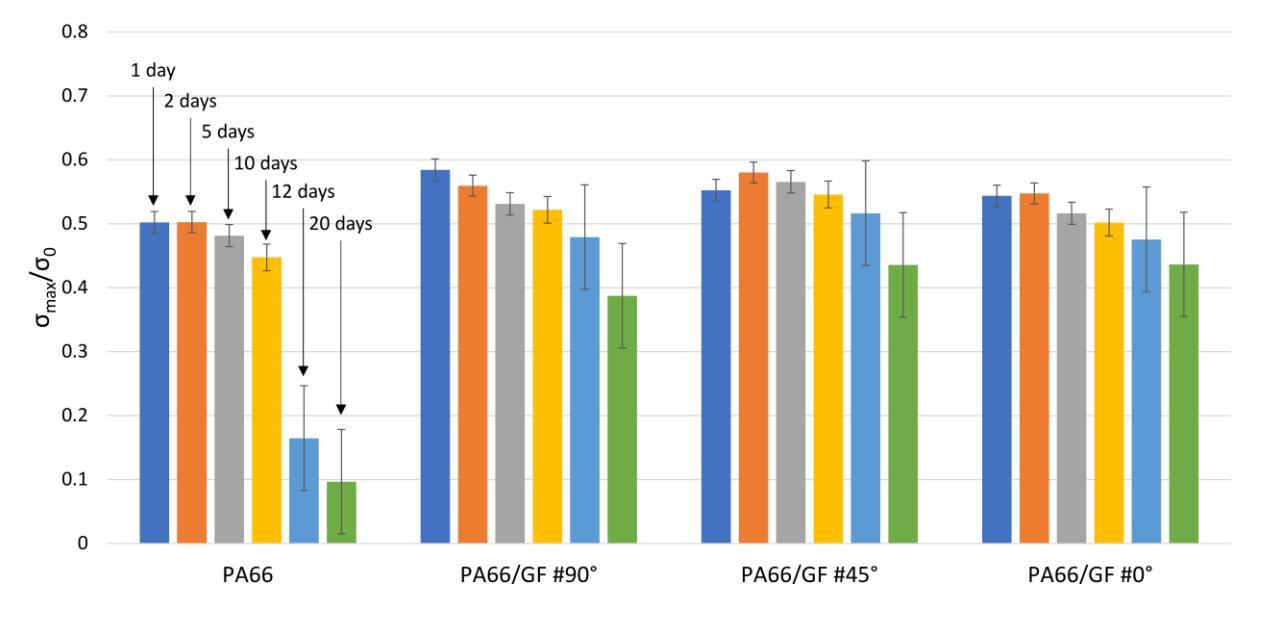
Figure 51. Evolution of the ultimate strength of unreinforced and short glass fiber reinforced PA66 samples aged in coolant for 1 day, 2 days, 5 days, 10 days, 12 days, and 20 days.

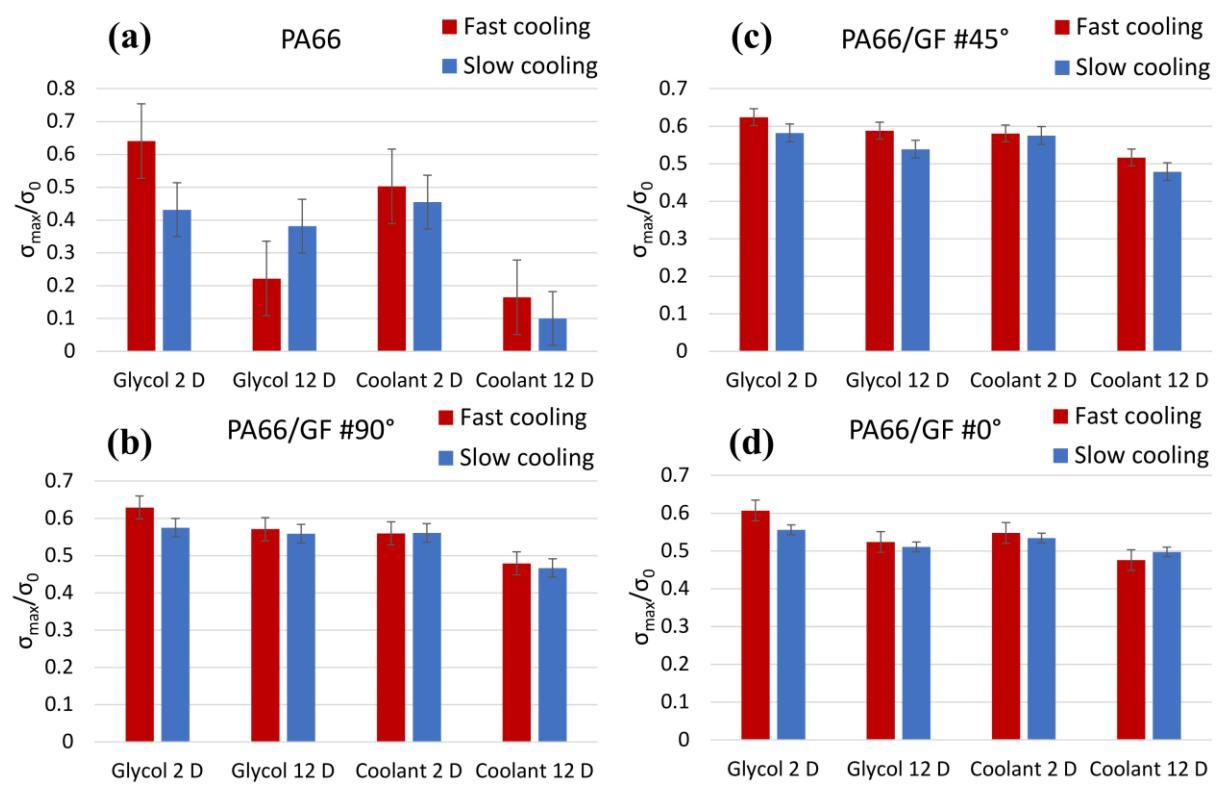
Figure 52. Evolution of the ultimate strength of unreinforced and short glass fiber reinforced PA66 samples aged in glycol for 2 days and 12 days using both fast-cooling and slow-cooling methods.

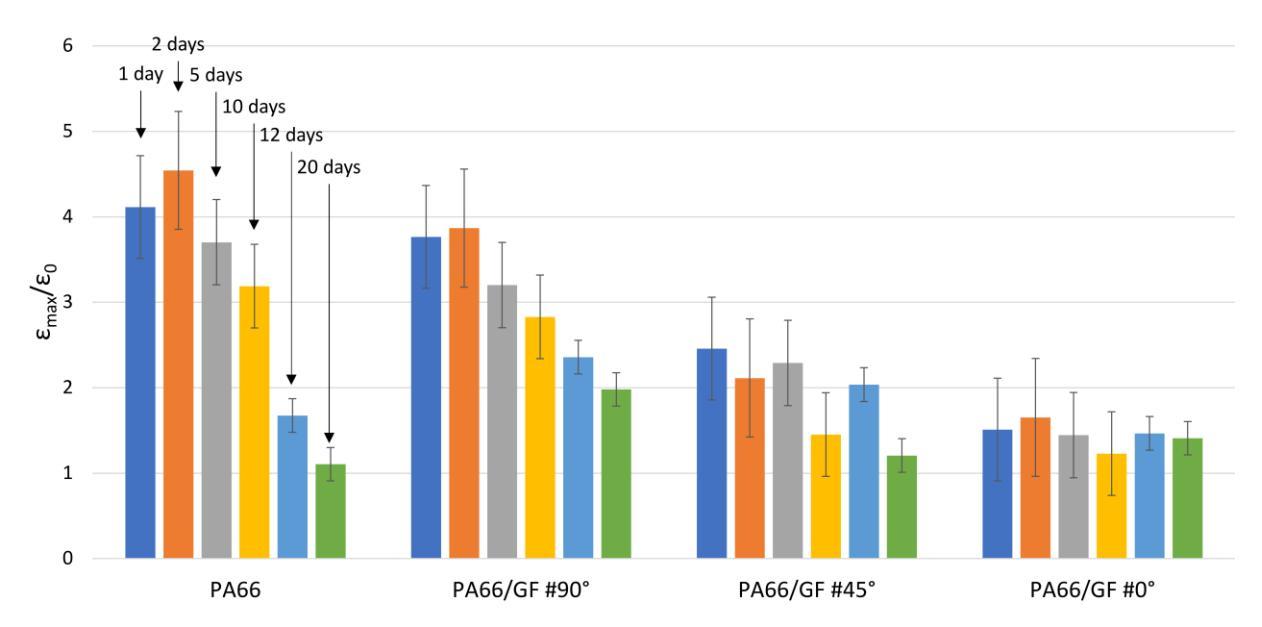
Figure 53. Evolution of the strain at failure of unreinforced and short glass fiber reinforced PA66 samples aged in glycol for 1 day, 2 days, 5 days, 10 days, 12 days, and 20 days.

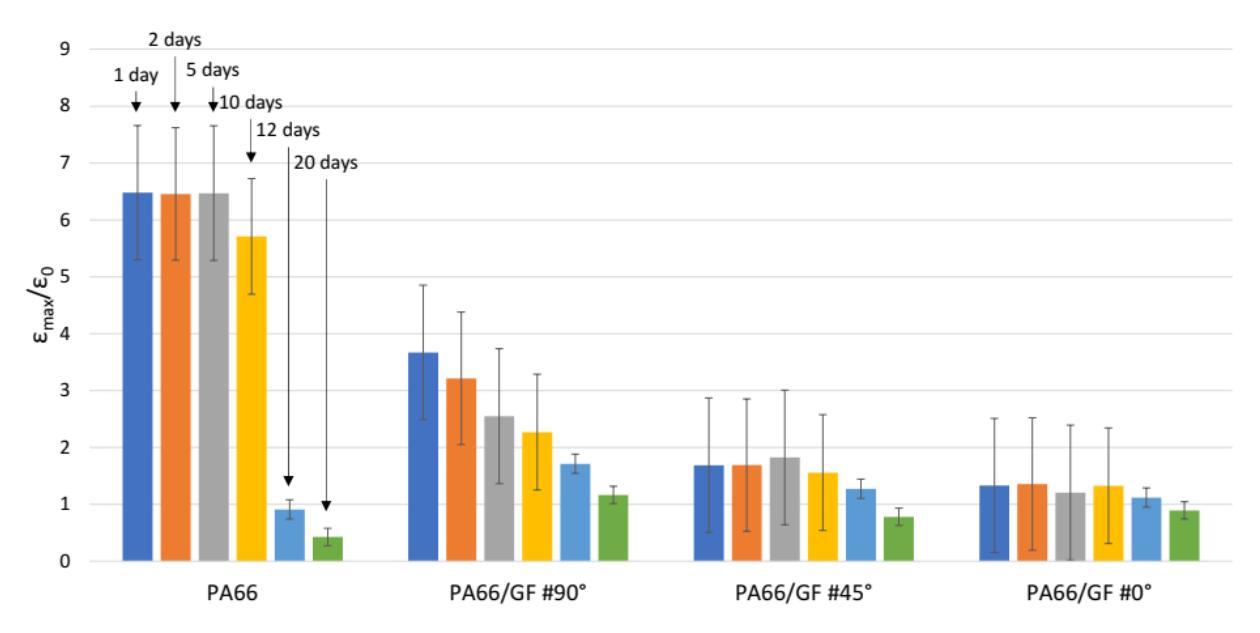
Figure 54. Evolution of the strain at failure of unreinforced and short glass fiber reinforced PA66 samples aged in coolant for 1 day, 2 days, 5 days, 10 days, 12 days, and 20 days.

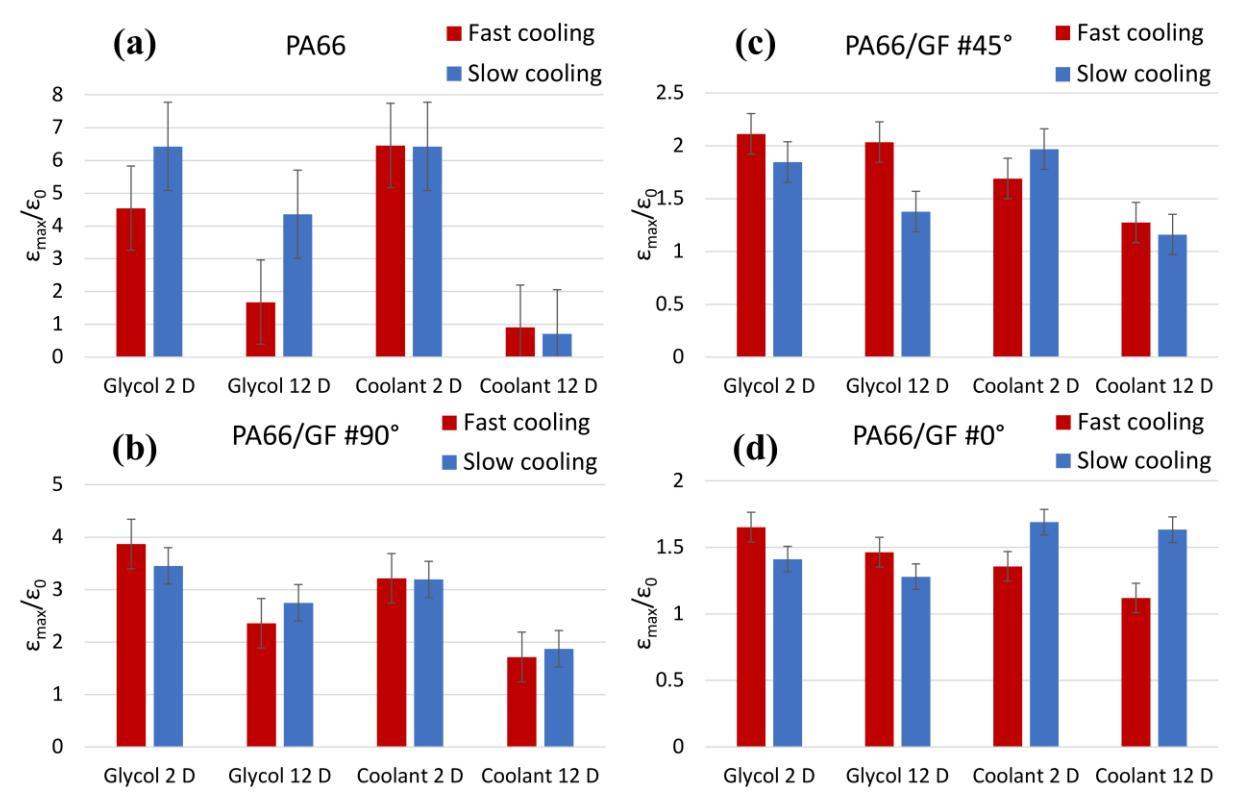
Figure 55. Evolution of the strain at failure of unreinforced and short glass fiber reinforced PA66 samples aged in glycol and coolant for 2 days and 12 days for both fast-cooling and slow-cooling methods.

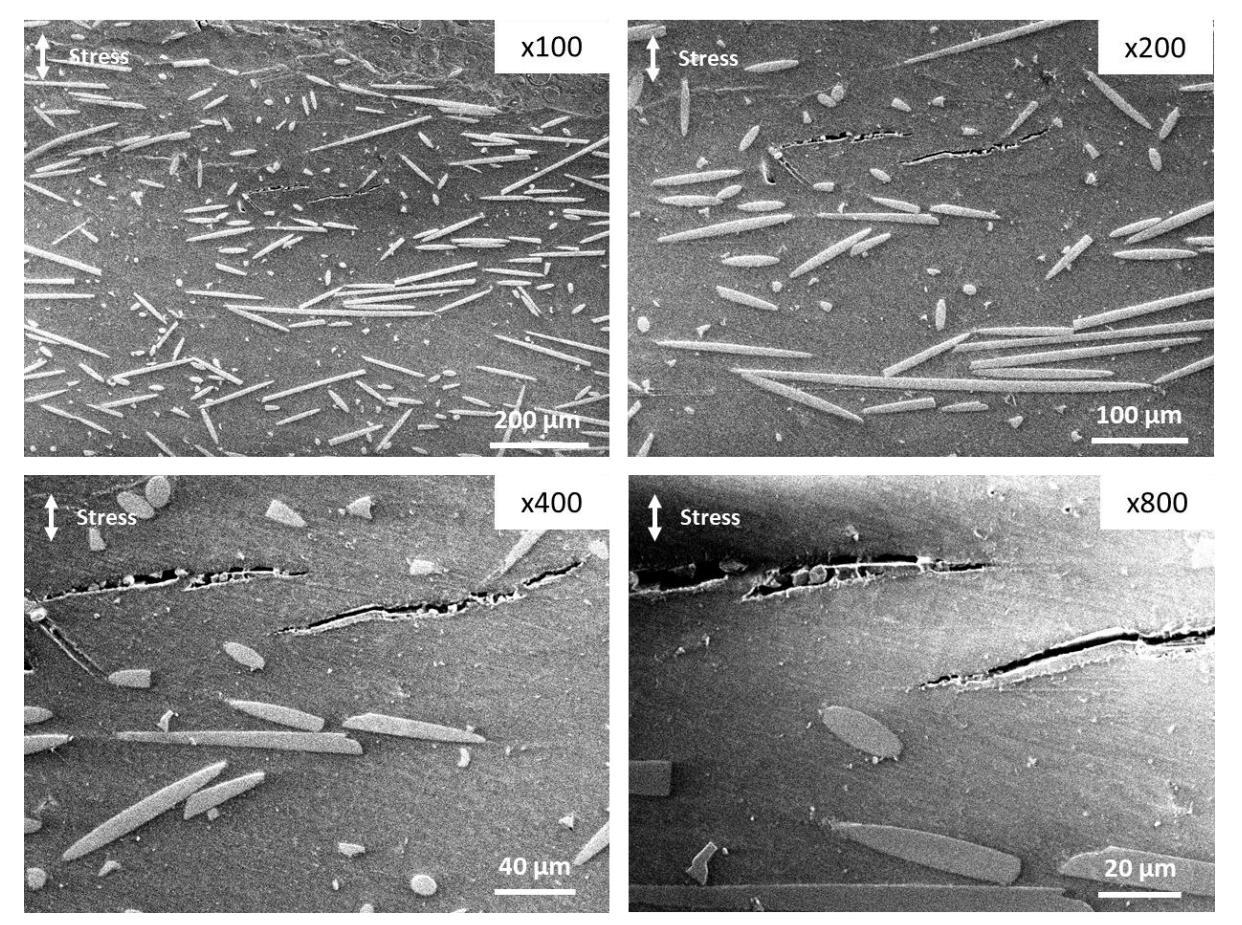
Figure 58. 10 days glycol aged PA66/GF samples at 90° SEM observations at different magnifications: x100, x200, x400, and x800. Each magnification allowing to determine the fiber orientation distribution in the material, to identify the damage location, and to define the nature of the occurring damage mechanisms.

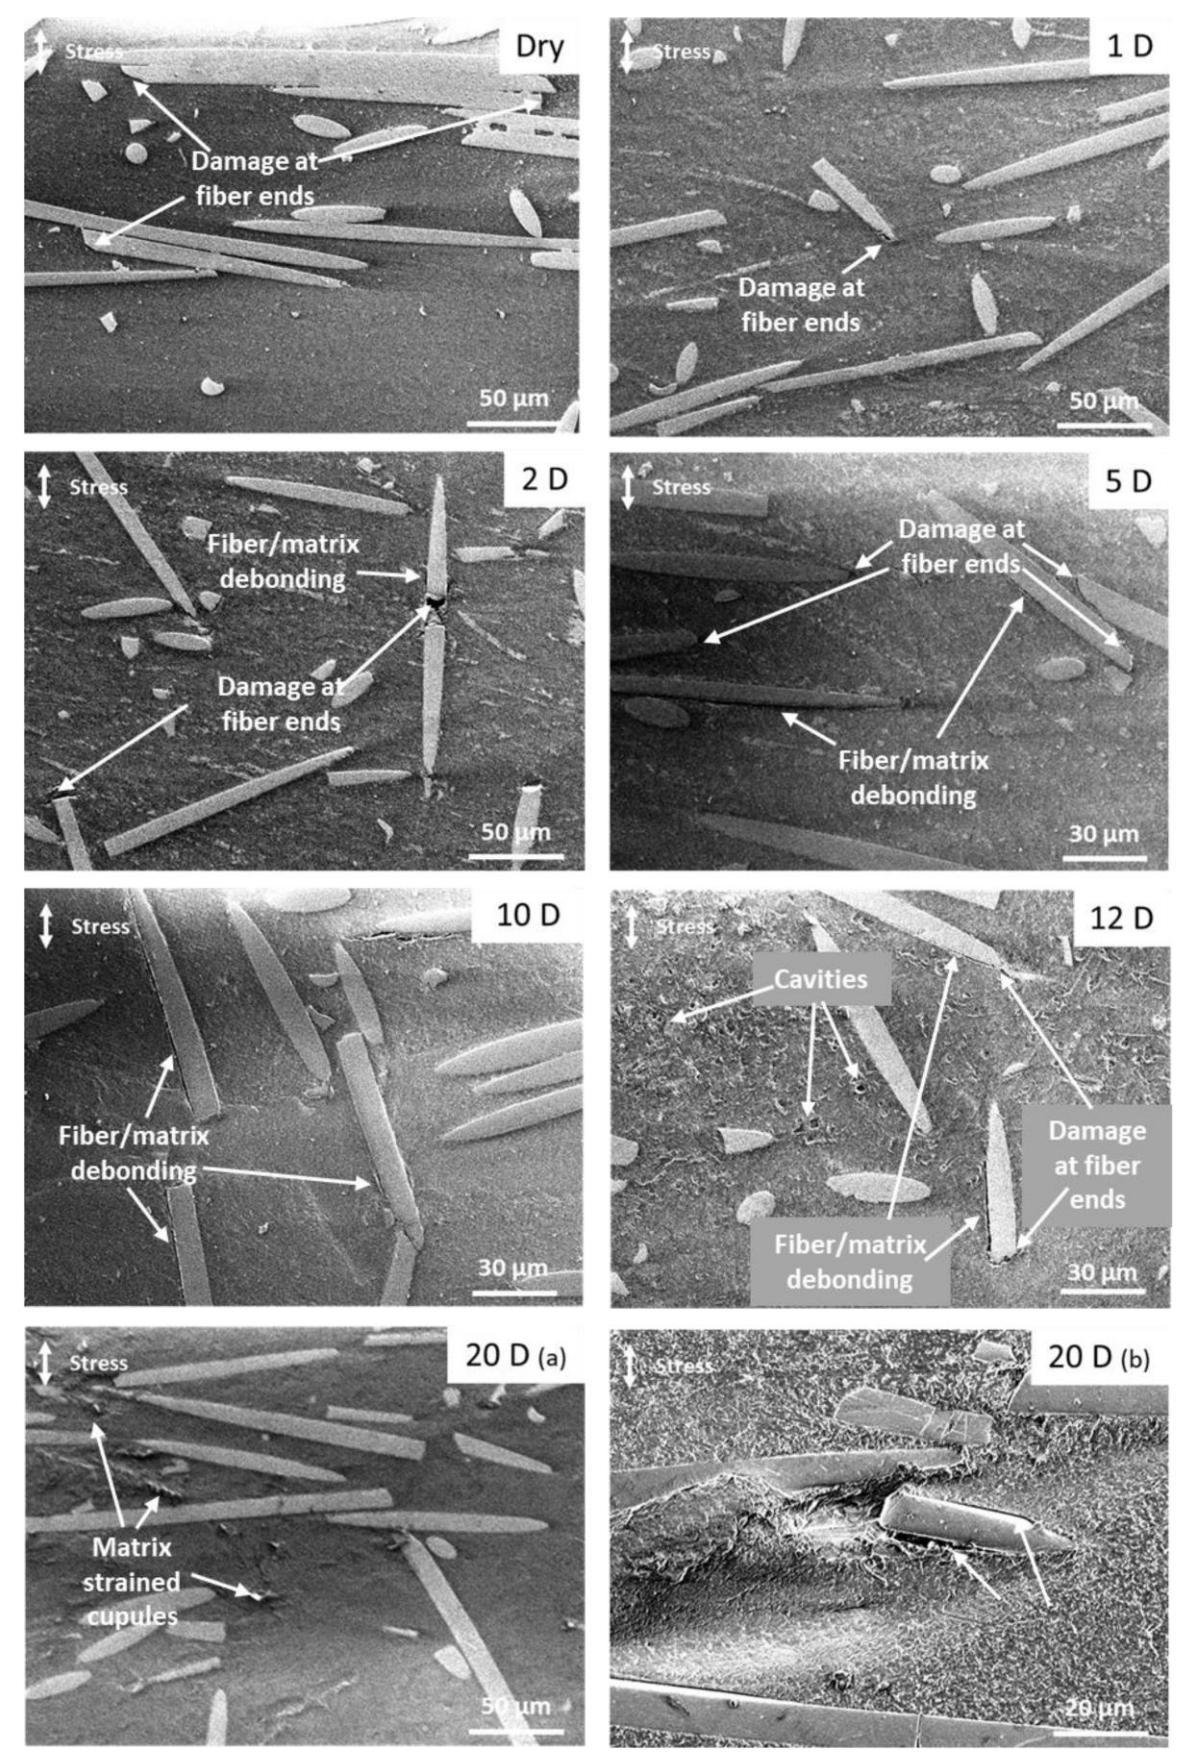
Figure 59. SEM observations for PA66/GF samples at 90° unaged (dry), 1 day, 2 days, 5 days, 10 days, 12 days and 20 days aged in glycol. The predominant damage mechanisms are damage at fiber ends and matrix/fiber debonding.

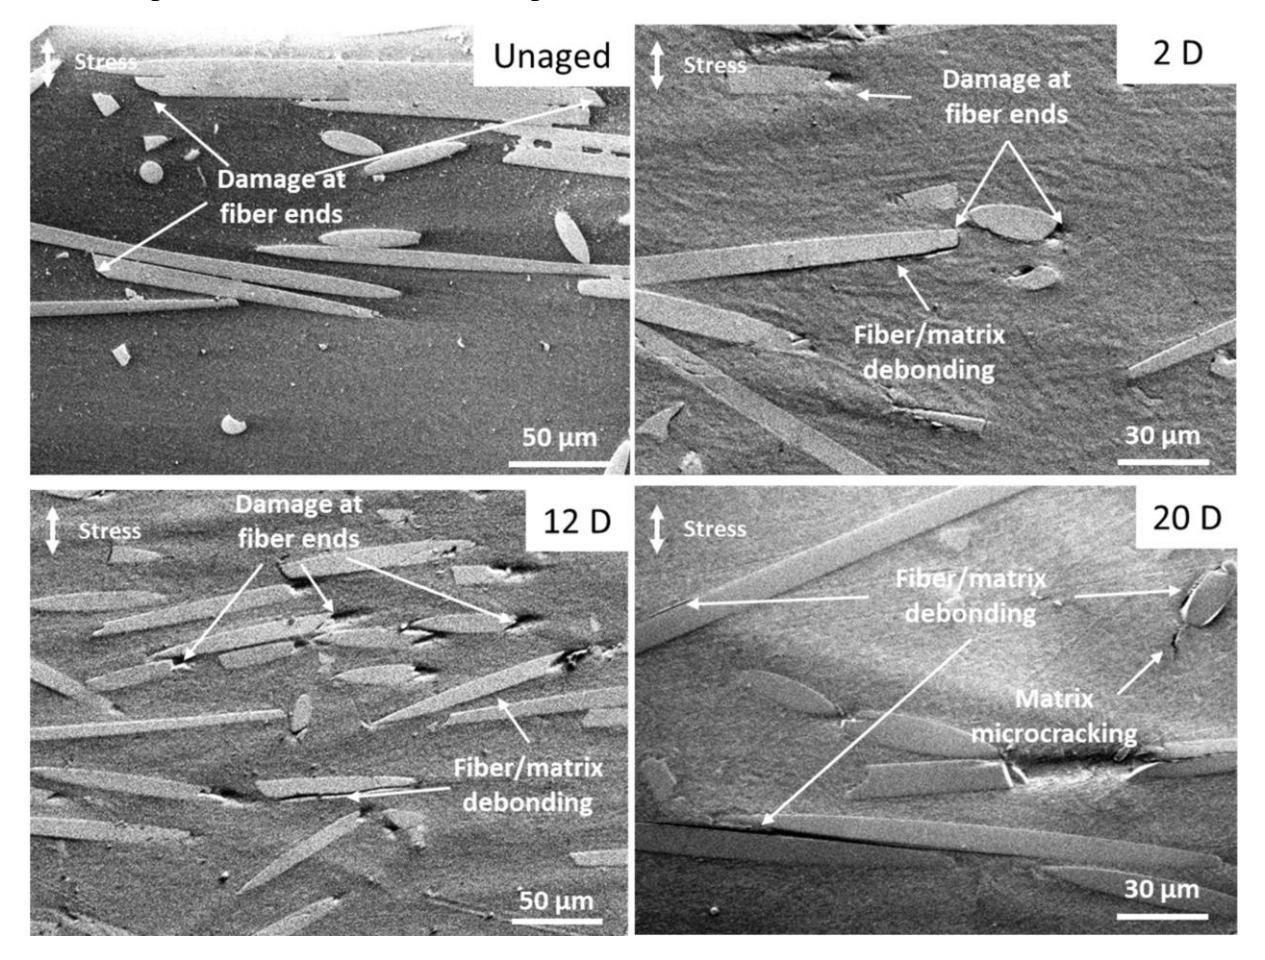
Figure 60. SEM observations for PA66/GF samples at 90° unaged (dry), 2 days, 12 days and 20 days aged in coolant. The predominant damage mechanisms are damage at fiber ends and matrix/fiber debonding.

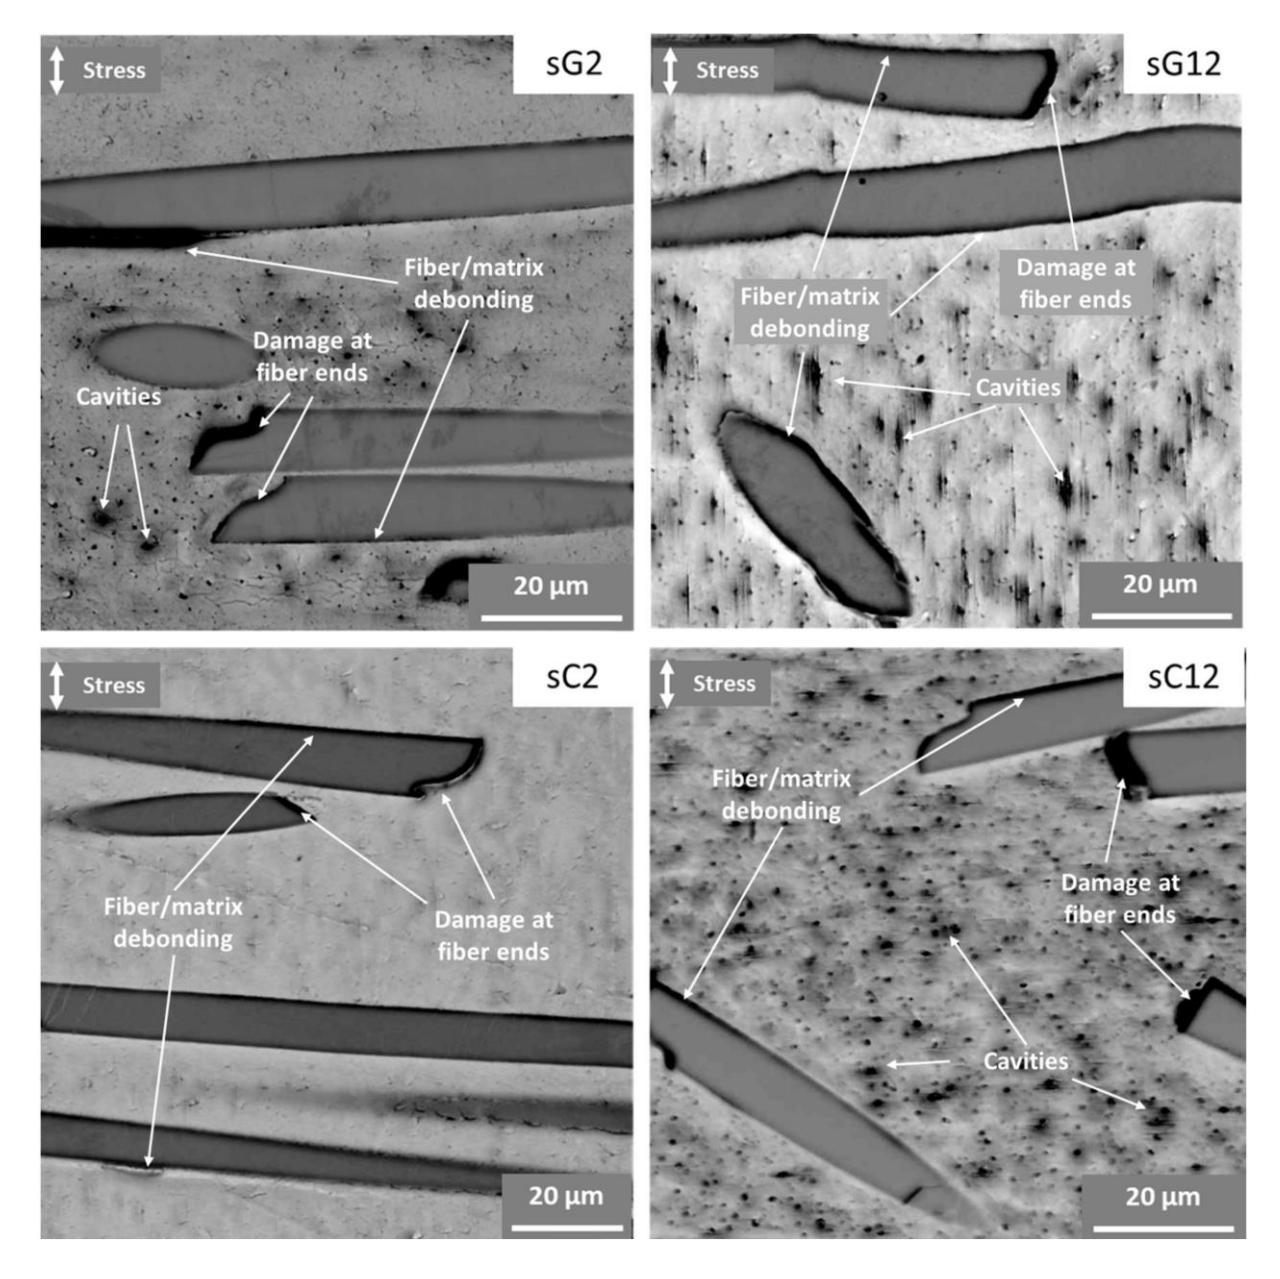
Figure 61. SEM observations for PA66/GF samples at 90° aged in glycol and coolant for 2 days and 12 days, using the slow cooling method. sG2 and sG12 represent the glycol aged samples for 2 and 12 days respectively, and sC2 and sC12 represent the coolant aged samples for 2 and 12 days respectively.

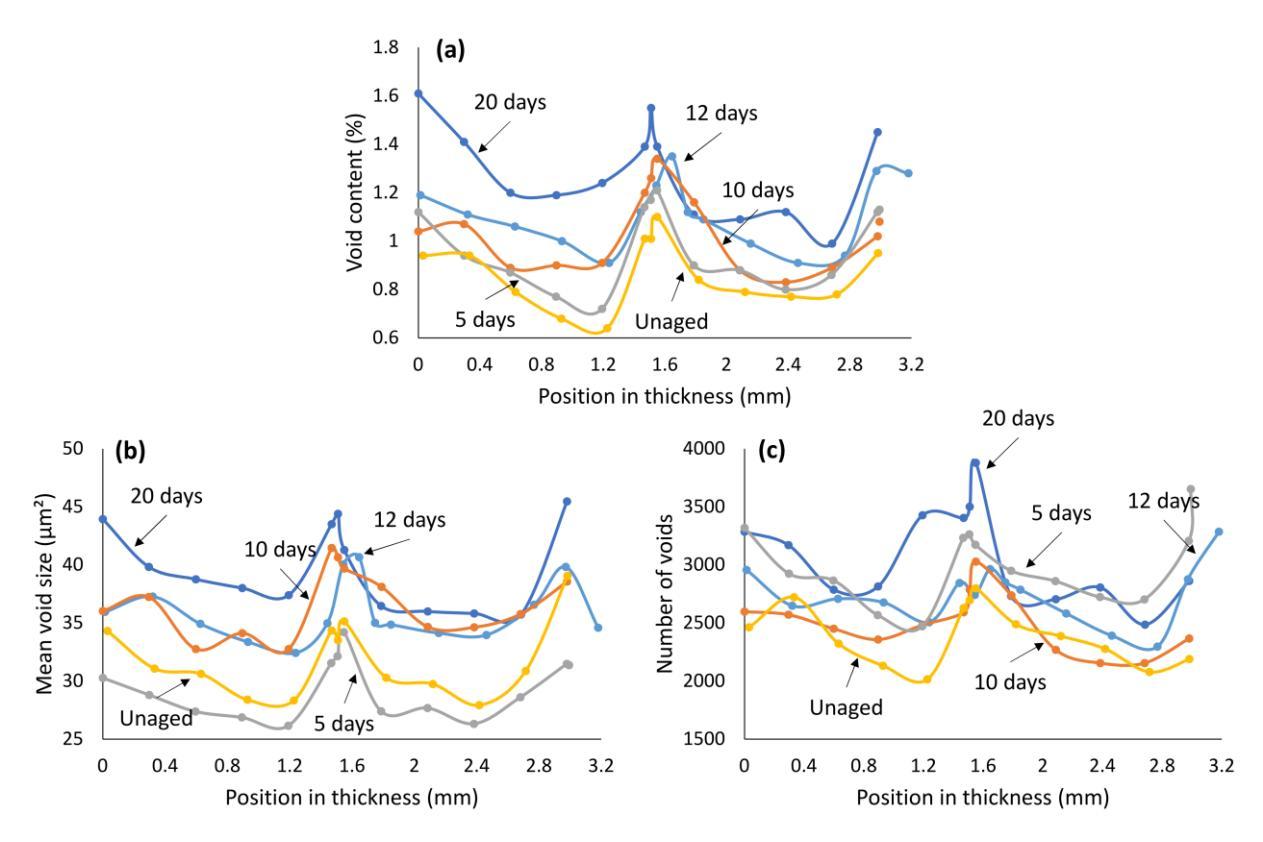
Figure 64. X-ray micro-tomography void investigation through the thickness of PA66/GF samples with 90° oriented fibers. The investigation is conducted for both unaged and aged samples in glycol for 5 days, 10 days, 12 days and 20 days. (a) Void content (%). (b) Mean void size. (c) Number of voids.

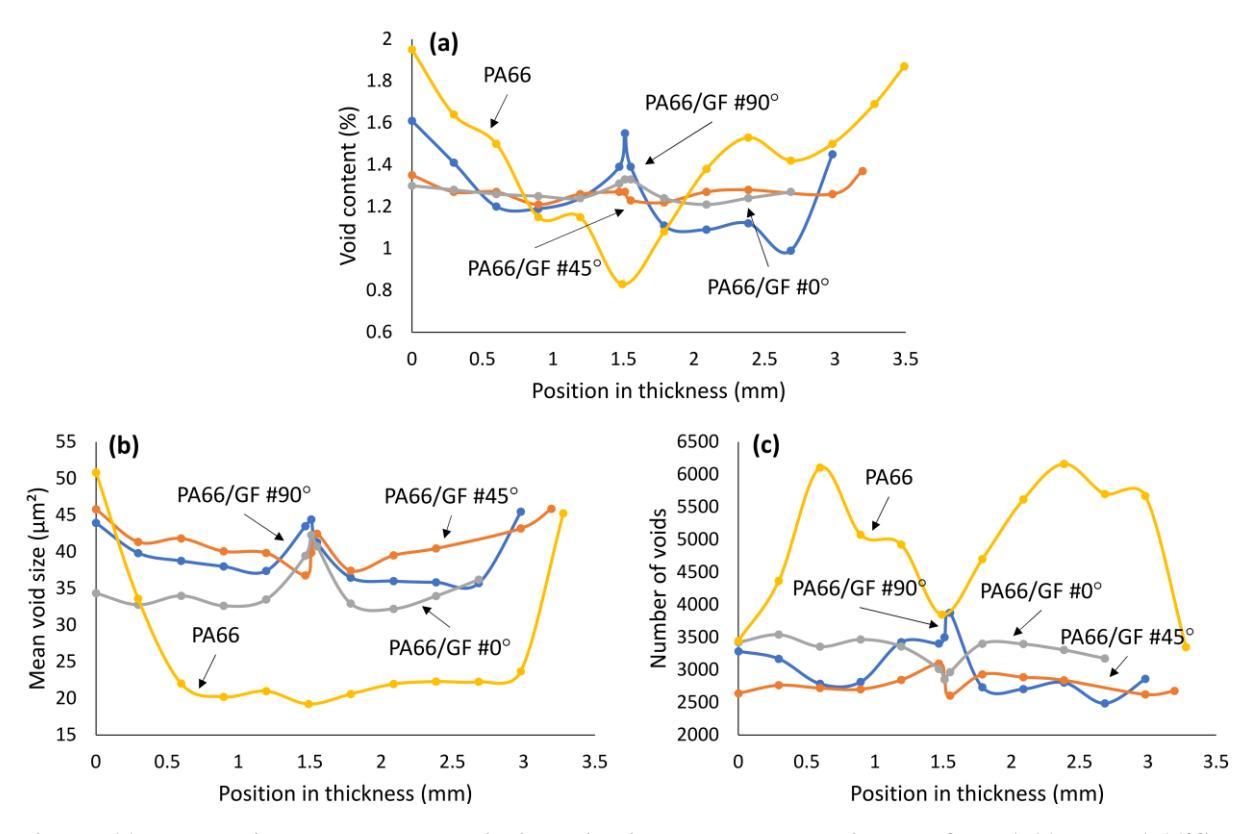
Figure 66. X-ray micro-tomography void investigation through the thickness for PA66 and PA66/GF samples with 0°, 45° and 90° oriented fibers, aged in glycol for 20 days. (a) Void content (%). (b) Void mean size. (c) Number of voids.

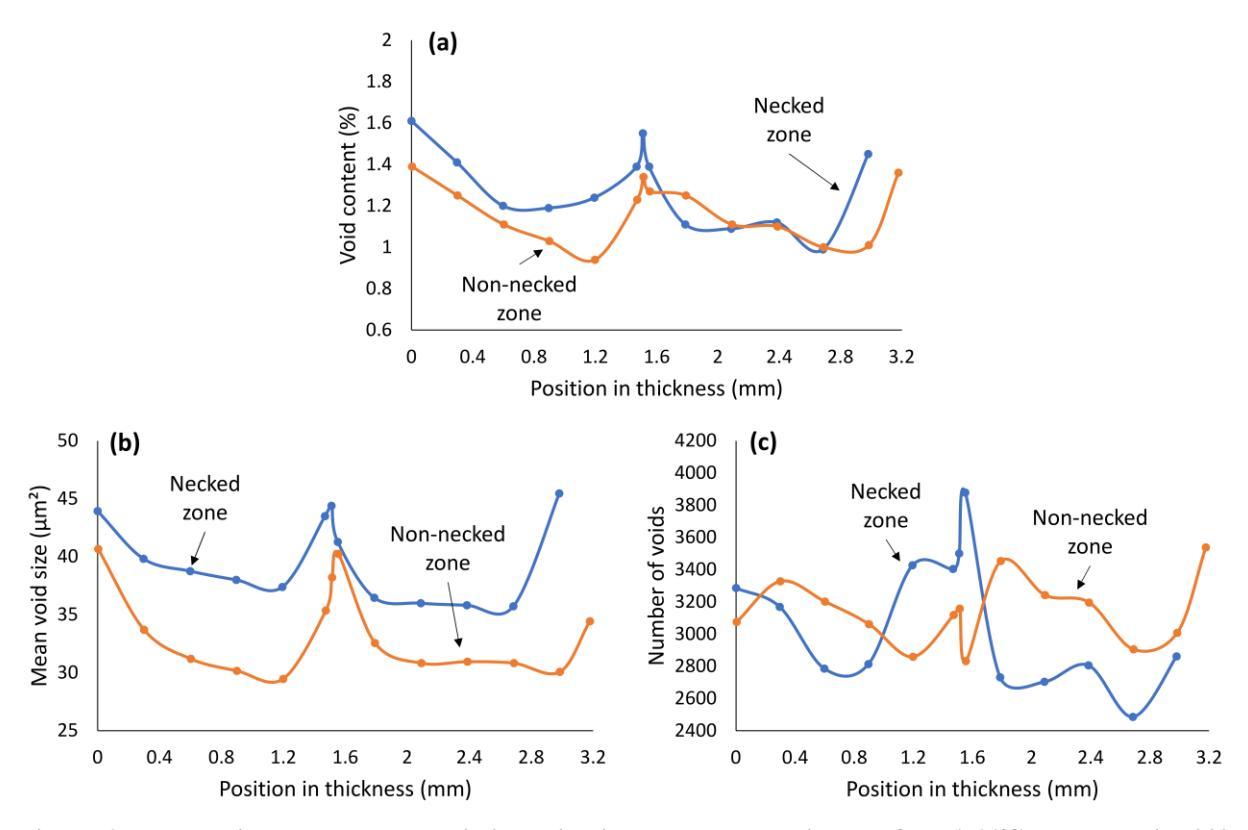
Figure 67. X-ray micro-tomography void investigation through the thickness for PA66/GF sample with 90° fiber orientation aged for 20 days, in the necked zone next to the rupture area and in the non-necked zone far from the rupture area. (a) Void content (%). (b) Void mean size. (c) Number of voids.

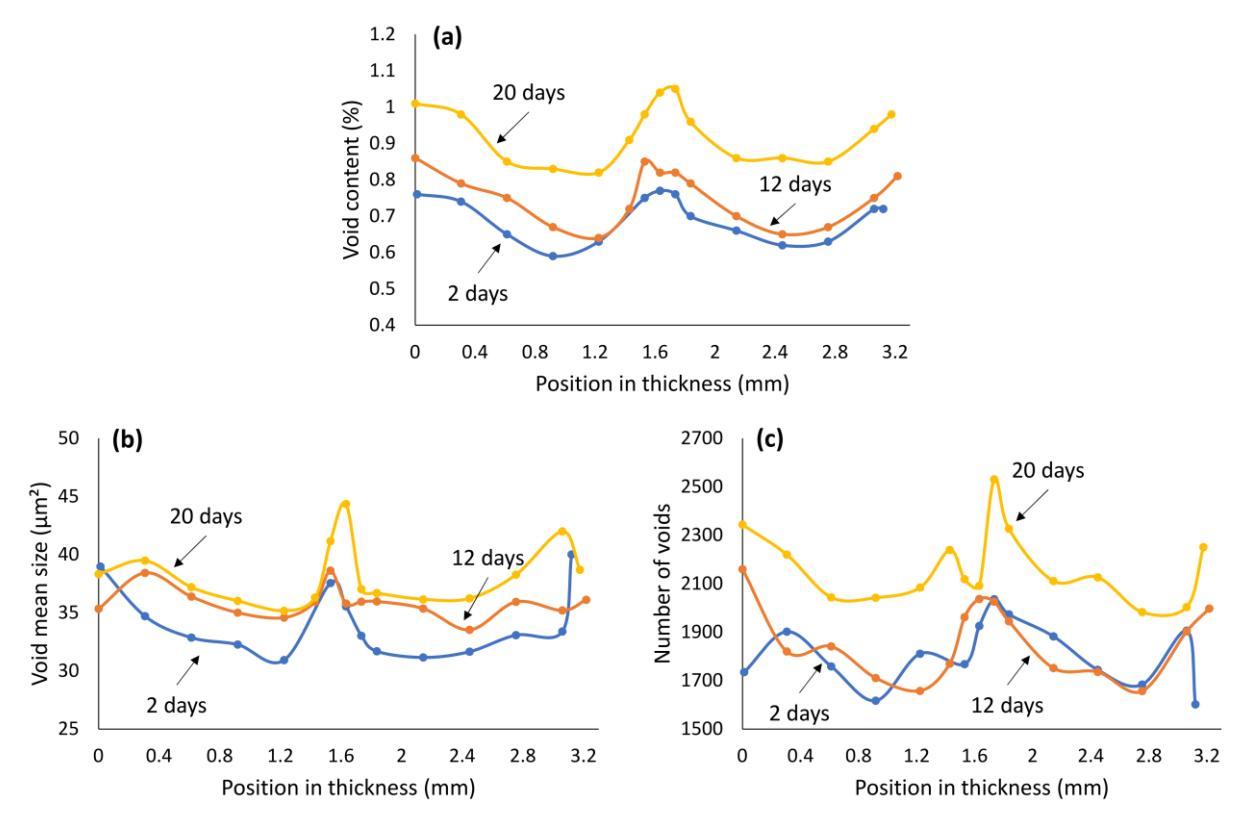
Figure 68. X-ray micro-tomography void investigation through the thickness prior to mechanical loading for PA66/GF samples with 90° oriented fibers, aged in coolant for 2, 12 and 20 days. (a) Void content (%). (b) Void mean size. (c) Number of voids.

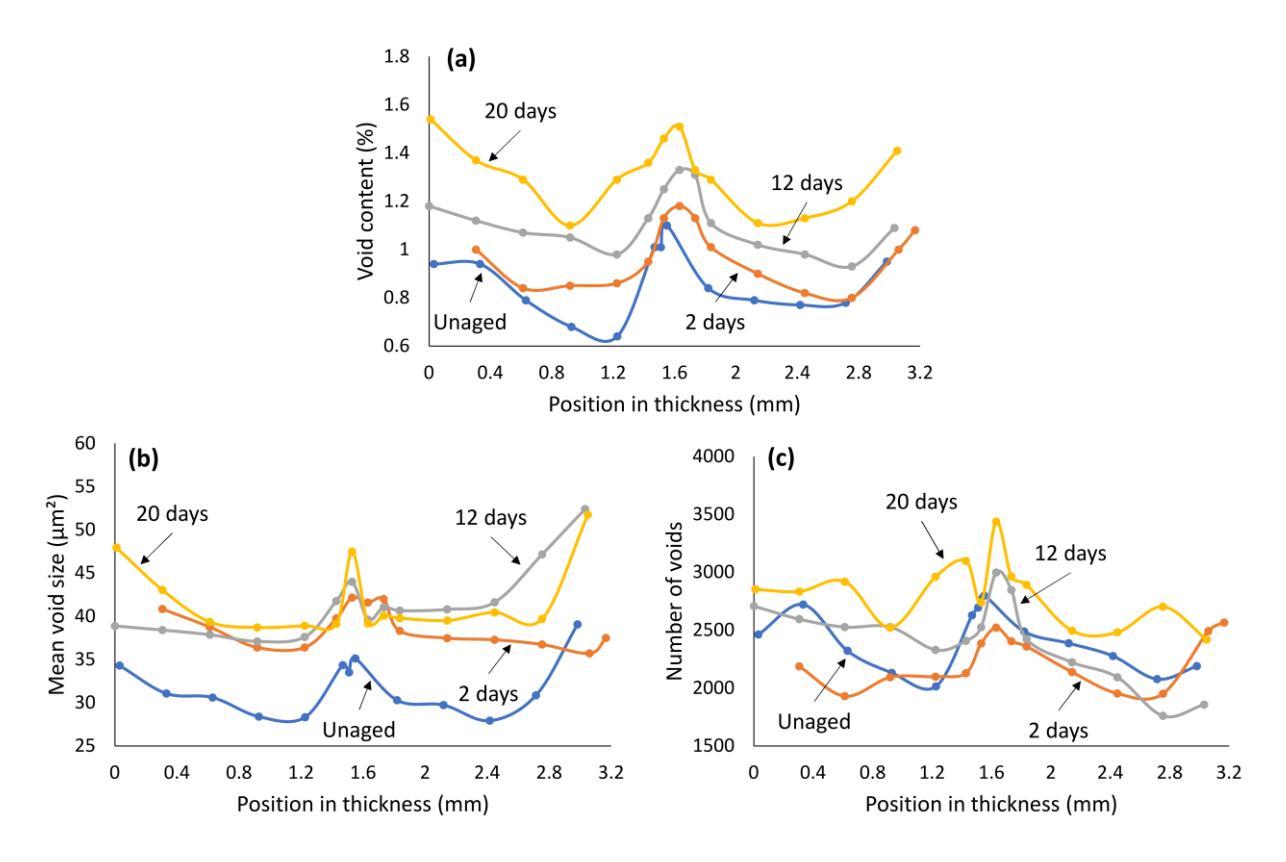
Figure 69. X-ray micro-tomography void investigation through the thickness of PA66/GF samples with 90° oriented fibers. The investigation is conducted after mechanical loading, for both unaged and aged samples in coolant for 2 days, 12 days, and 20 days. (a) Void content (%). (b) Mean void size. (c) Number of voids.

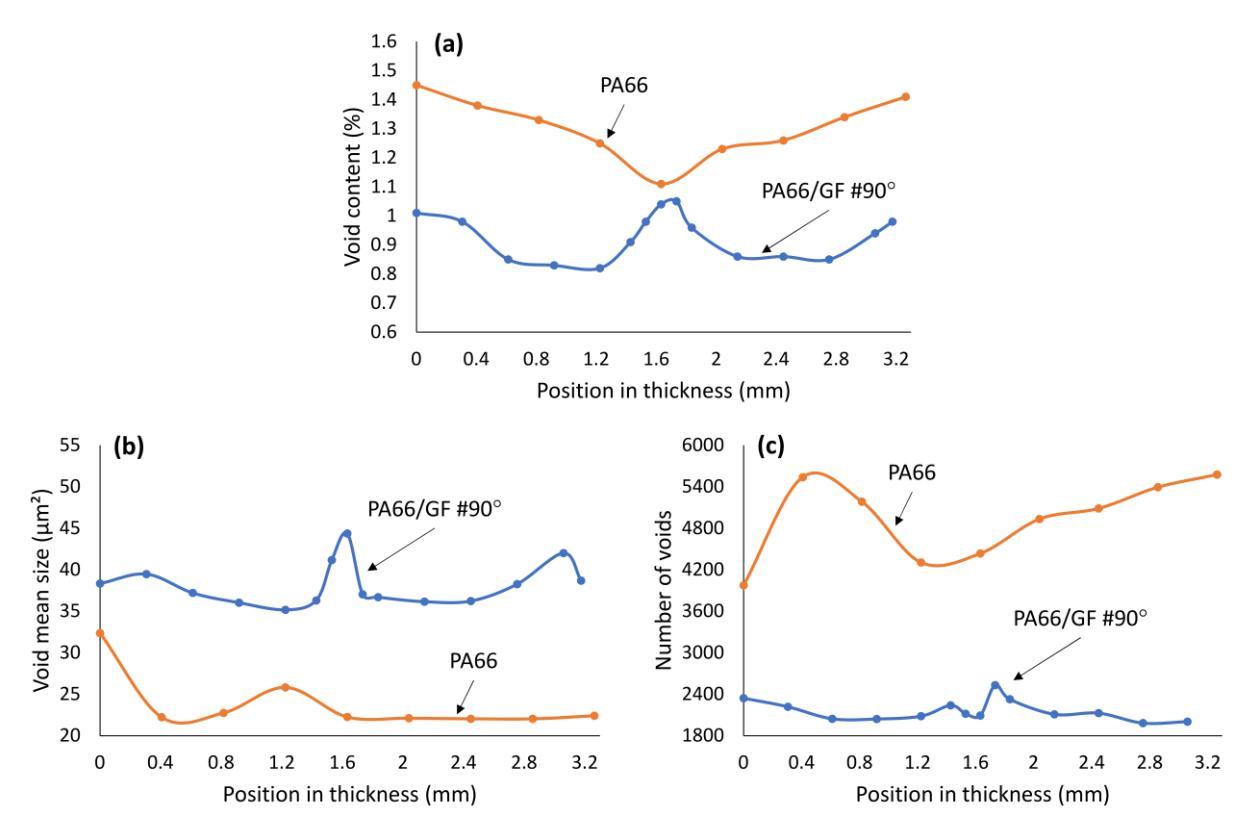
Figure 70. X-ray micro-tomography void investigation through the thickness prior to mechanical loading for PA66 and PA66/GF samples with 90° oriented fibers, aged in coolant for 20 days. (a) Void content (%). (b) Void mean size. (c) Number of voids.

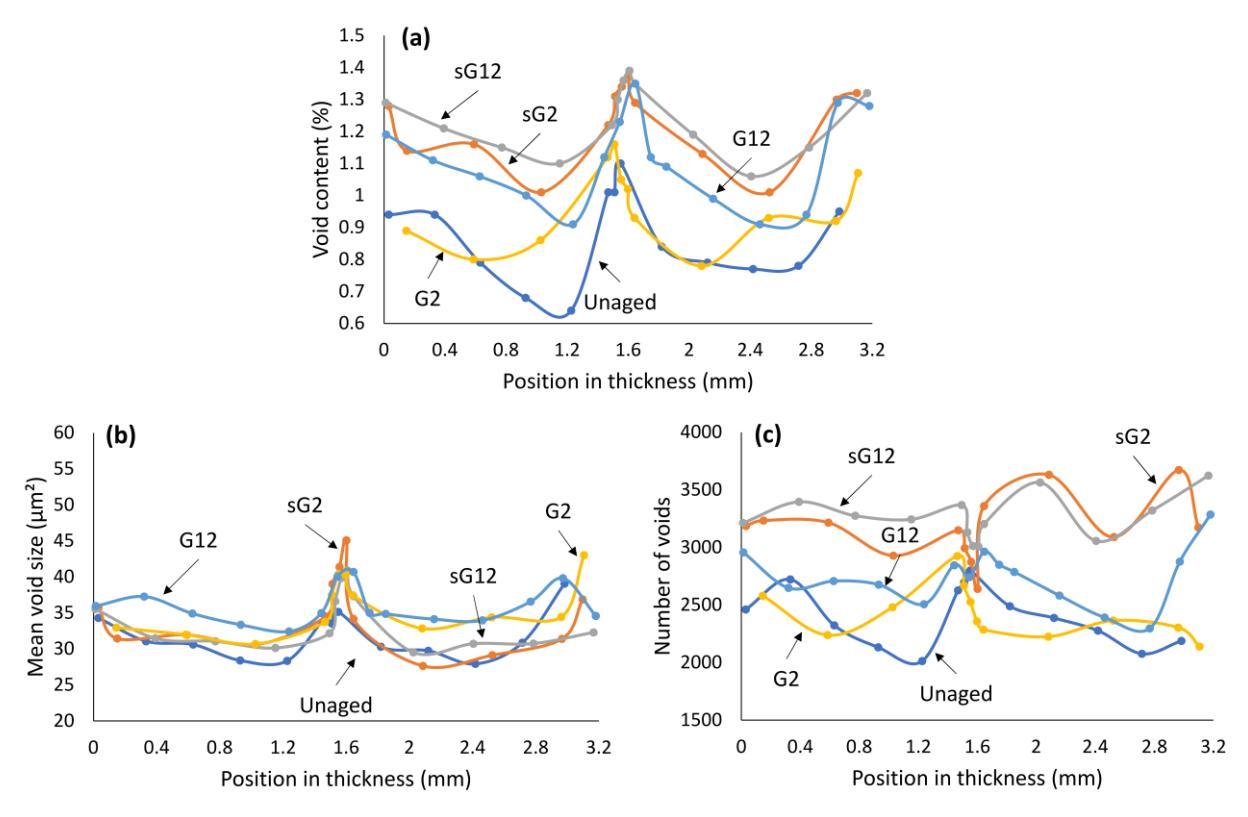
Figure 71. X-ray micro-tomography void investigation through the thickness of PA66/GF samples with 90° oriented fibers. The investigation is conducted for both unaged, and aged samples in glycol for 2 and 12 days, using the slow and fast cooling methods. sG2 and sG12 represent the glycol aged samples for 2 and 12 days respectively using the slow-cooling method, and G2 and G12 represent the glycol aged samples for 2 and 12 days respectively using the fast-cooling method. (a) Void content (%). (b) Mean void size. (c) Number of voids.

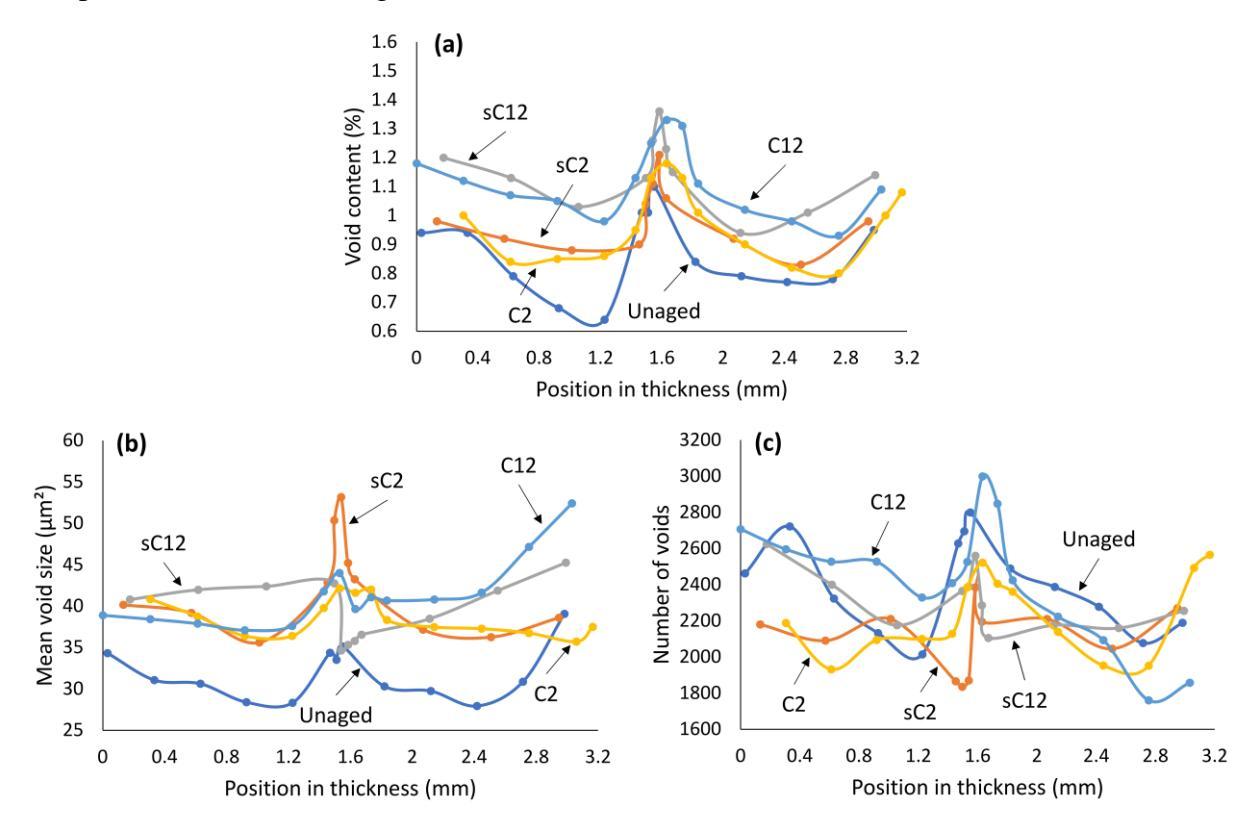
Figure 72. X-ray micro-tomography void investigation through the thickness of PA66/GF samples with 90° oriented fibers. The investigation is conducted for both unaged, and aged samples in coolant for 2 and 12 days, using the slow and fast cooling methods. sC2 and sC12 represent the coolant aged samples for 2 and 12 days respectively using the slow-cooling method, and C2 and C12 represent the coolant aged samples for 2 and 12 days respectively using the fast-cooling method. (a) Void content (%). (b) Mean void size. (c) Number of voids.

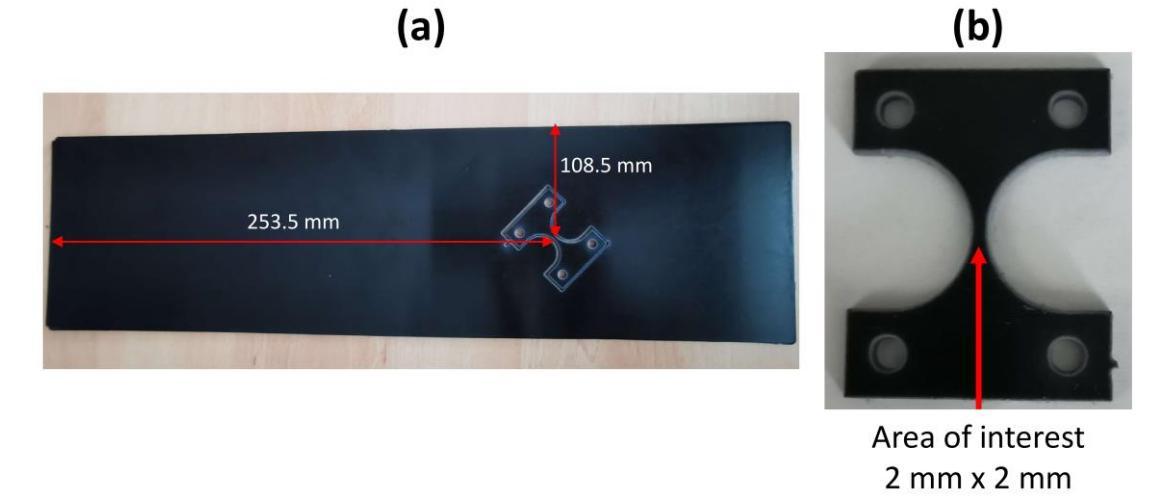
Figure 73. (a) Specimen's extraction position on PA66/GF injected plate. (b) Specimen's geometry for insitu tests using X-ray microtomography.
