Etude des mécanismes d'endommagement dans un polyamide 66 renforcé par des fibres de verre courtes, soumis à l'effet de vieillissement de l'éthylène glycol et de l'antigel

THÈSE

Damage mechanisms investigation in short glass-fiber reinforced polyamide 66 subjected to the aging effect of ethylene glycol and coolant

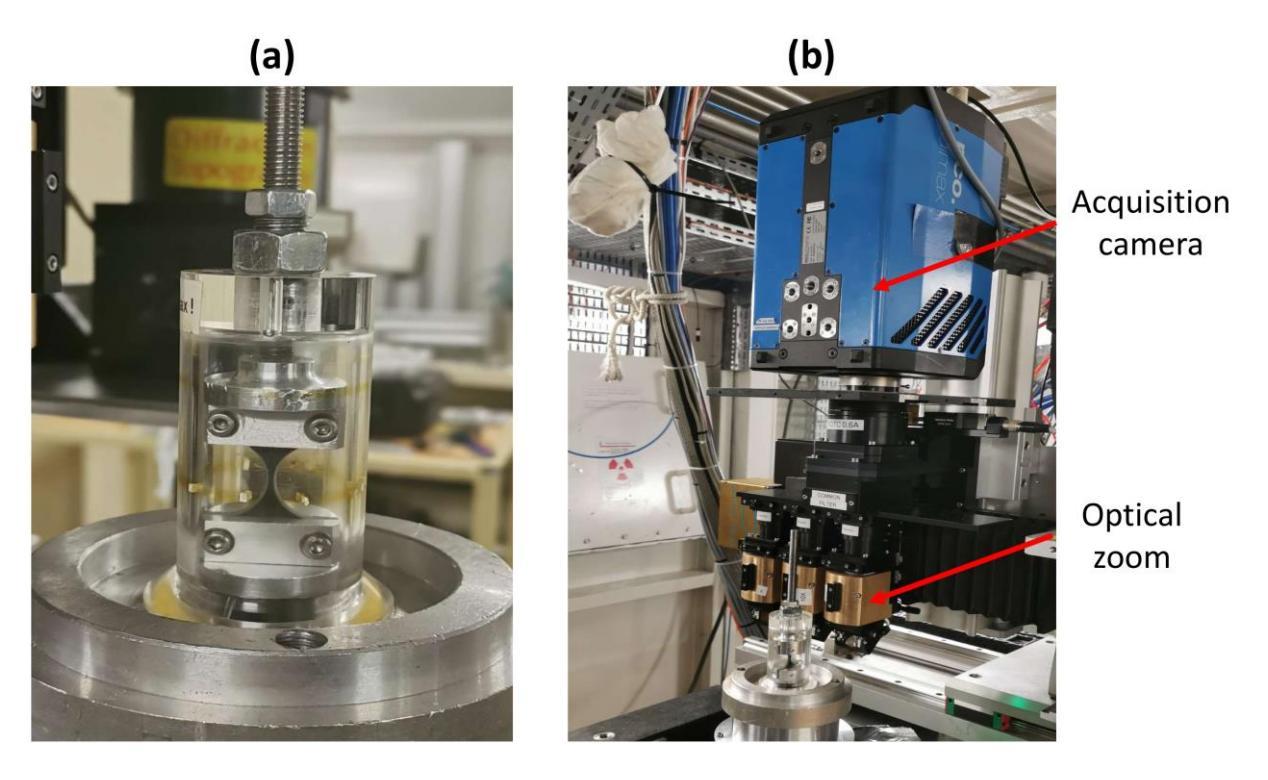
Figure 74. (a) In-situ monotonic tensile machine. (b) In-situ testing setup with the acquisition camera and the optical zoom.

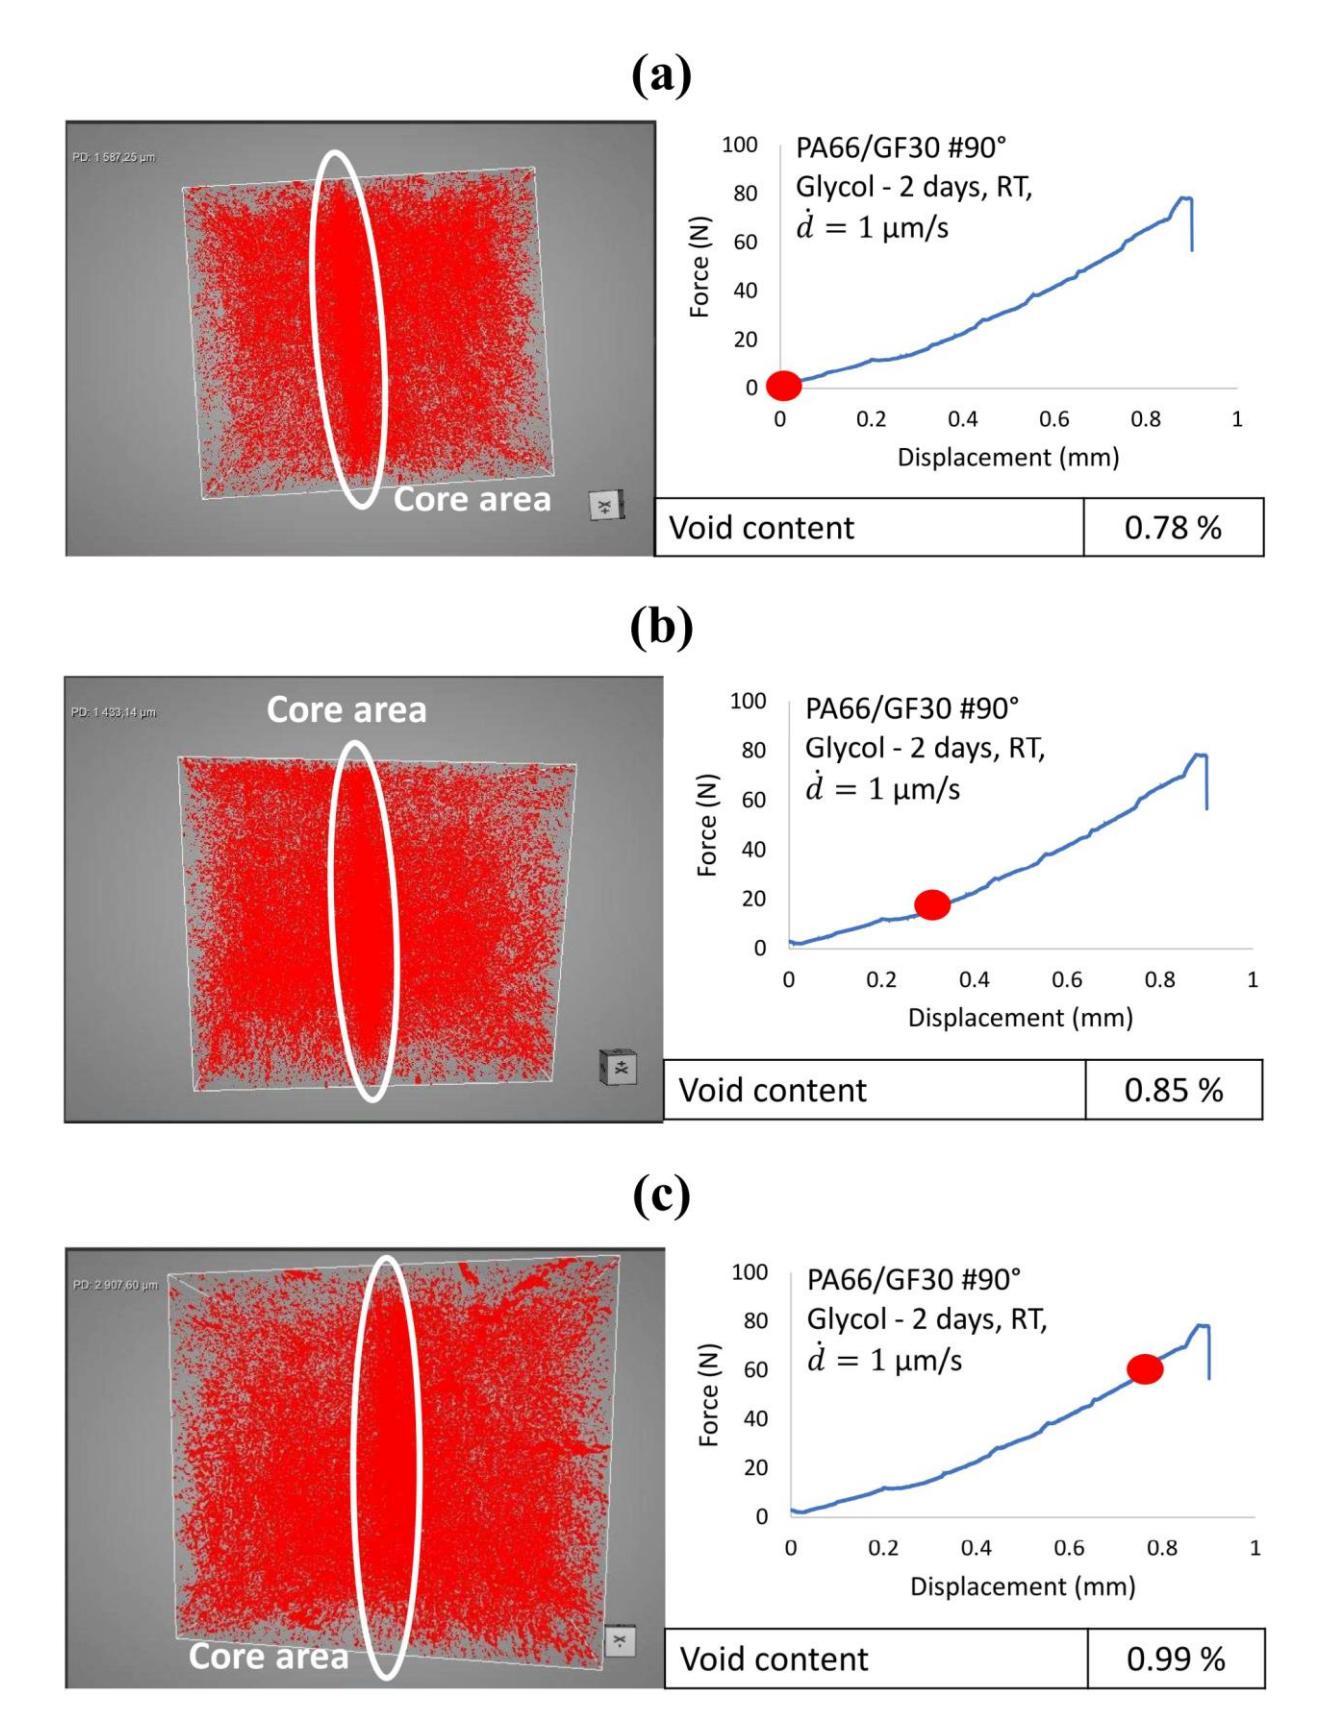
Figure 75. Void analyses on PA66/GF30 with 90° oriented fibers aged in glycol for 2 days, displaying void distribution in the reconstructed volume, mechanical response and void content. (a) PA66/GF30 #90° prior to loading. (b) PA66/GF30 #90° at 25 % Fmax. (c) PA66/GF30 #90° at 75 % Fmax.

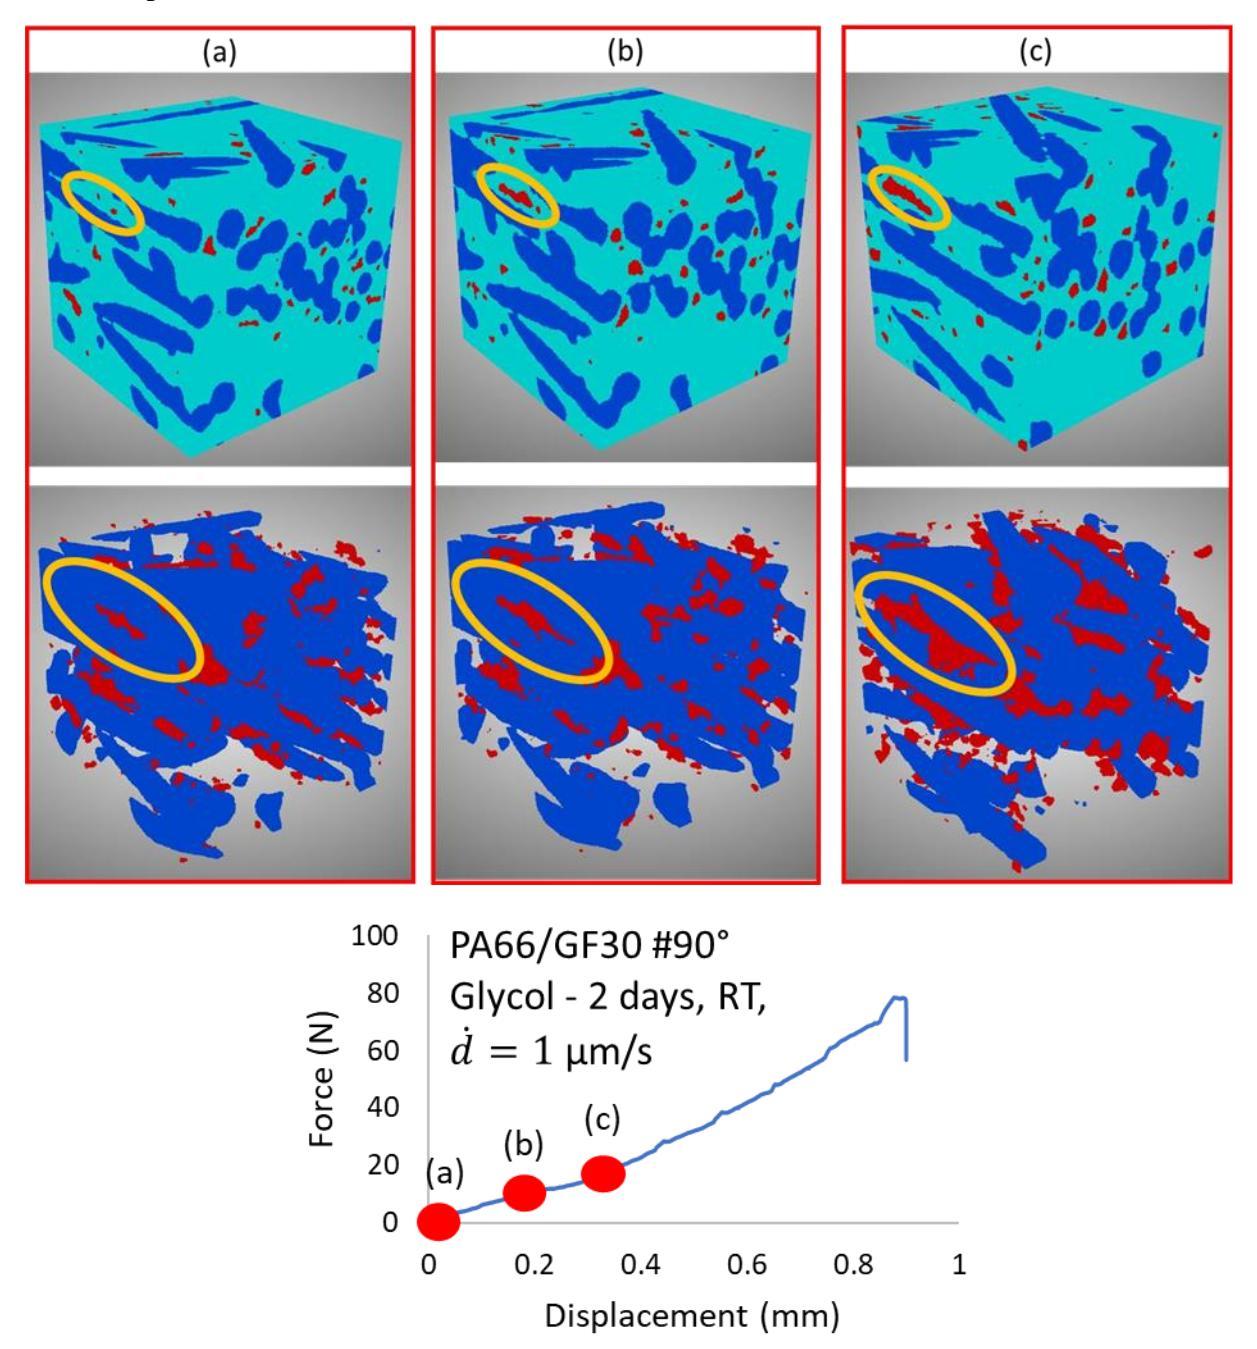
Figure 76. Damage evolution during in-situ X-ray microtomography testing for a PA66/GF30 specimen with 90° oriented fibers, aged in glycol for 2 days, displaying the damage distribution in the reconstructed volume, with the mechanical response.

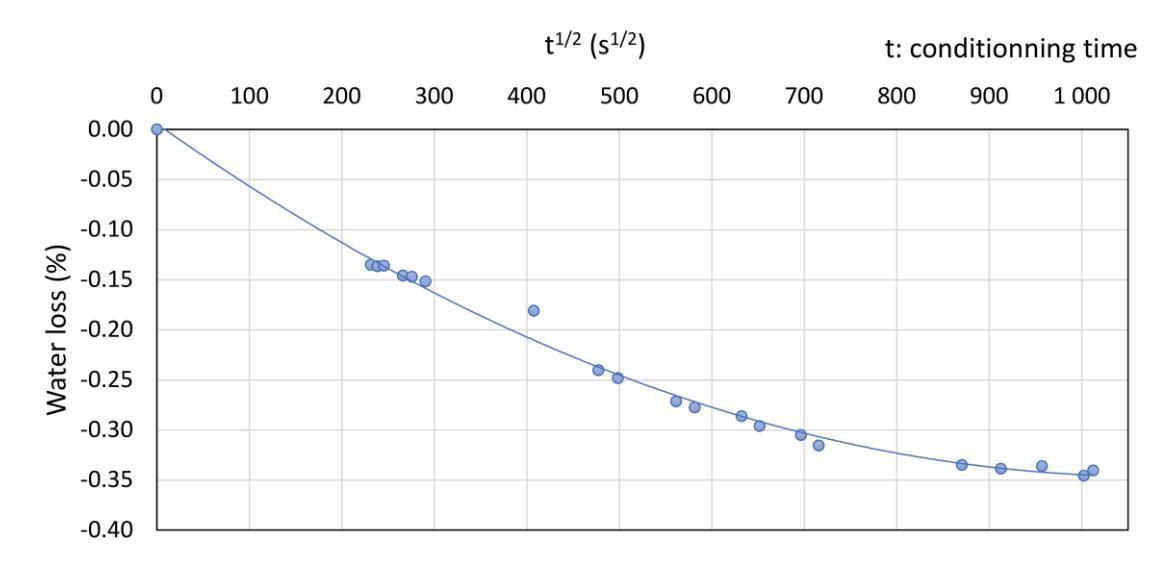
Figure 78. Water weight loss evolution in time of PA66 samples.

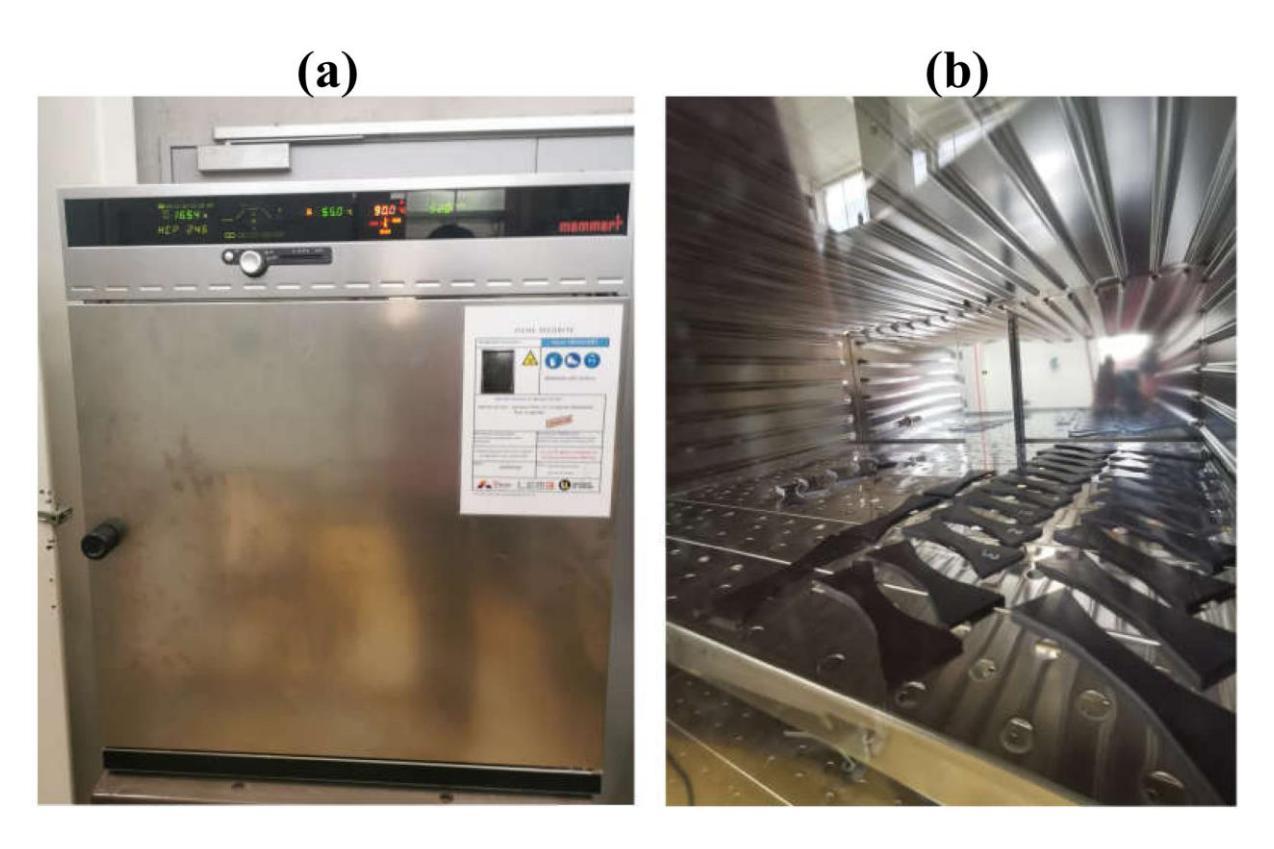
Figure 79. Hygrometric chamber used for samples' conditioning. (a) Memmert HCP246hygrometric chamber. (b) Dog bone samples placed in the hygrometric chamber.

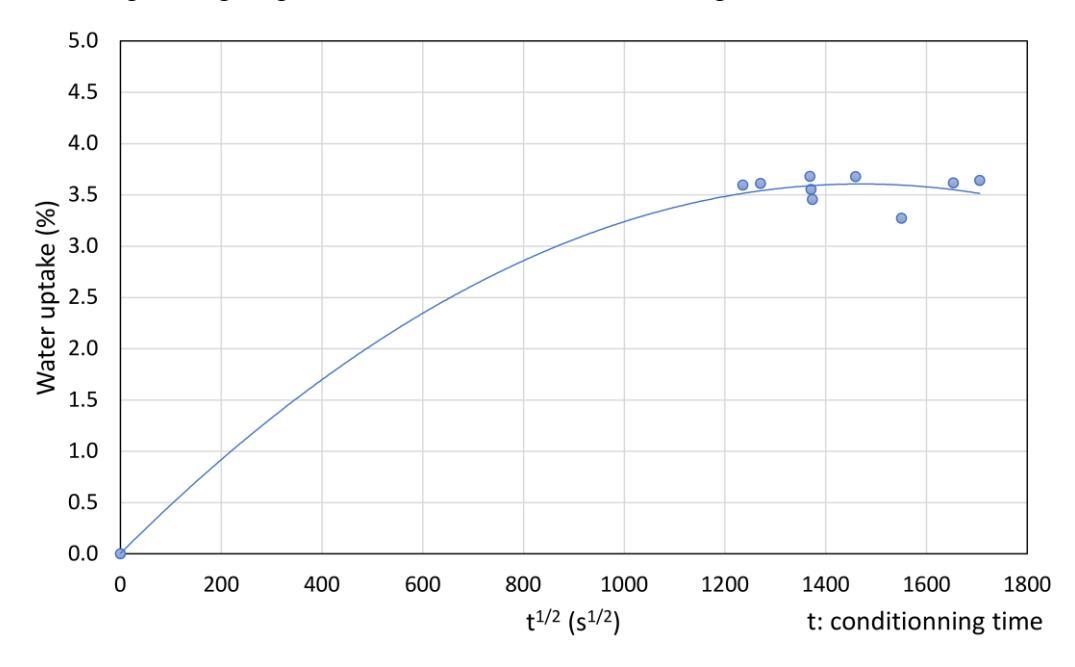
Figure 80. Water uptake evolution, for PA66 samples, as a function of the squared time.

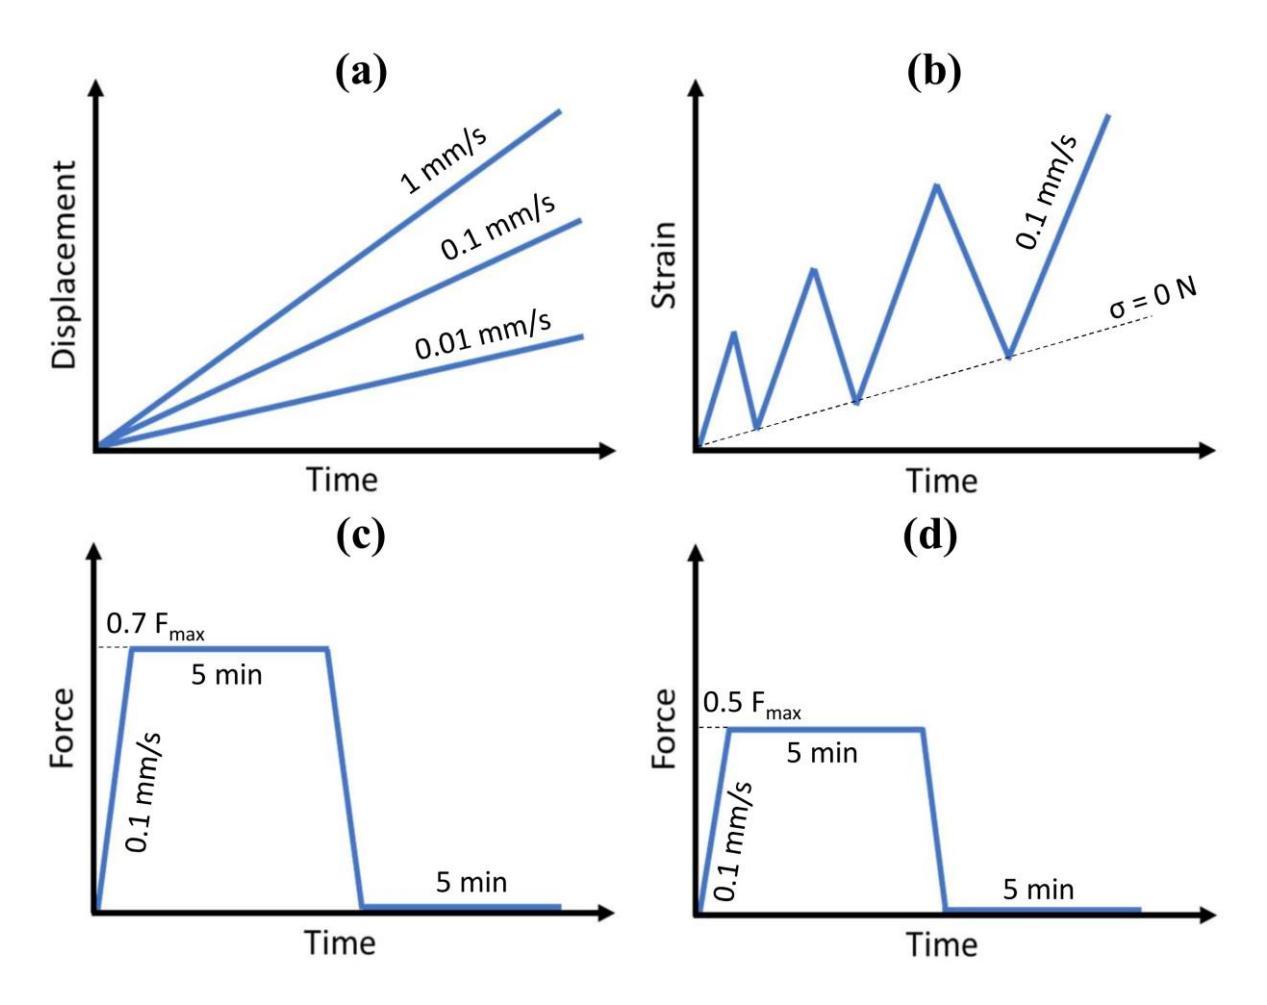
Figure 81. Schematic diagram for the mechanical tests used for calibration. (a) Monotonic displacementcontrolled test. (b) Load-unload test with strain level increase. (c) Creep-recovery test with 50 % F_{max} . (d) Creep-recovery test with 70 % F_{max} .

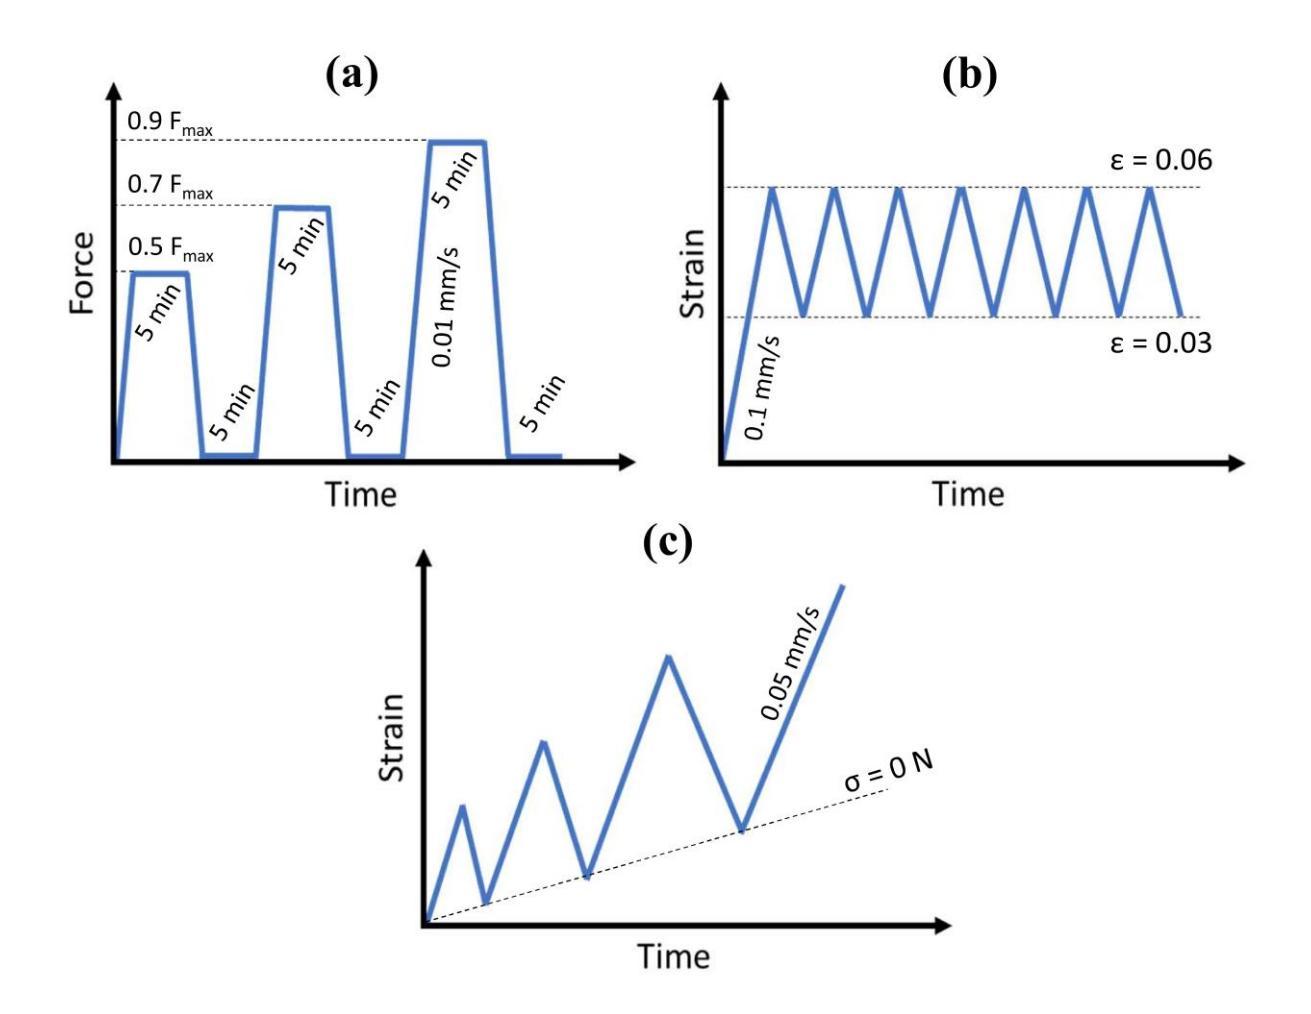
Figure 82. Input schemes for the mechanical tests used for validation. (a) Creep-recovery test with 50 %, 70 % and 90 % F_{max} . (b) Cyclic tensile test with R_{ϵ} = 0.5. (c) Load-unload test with strain level increase.

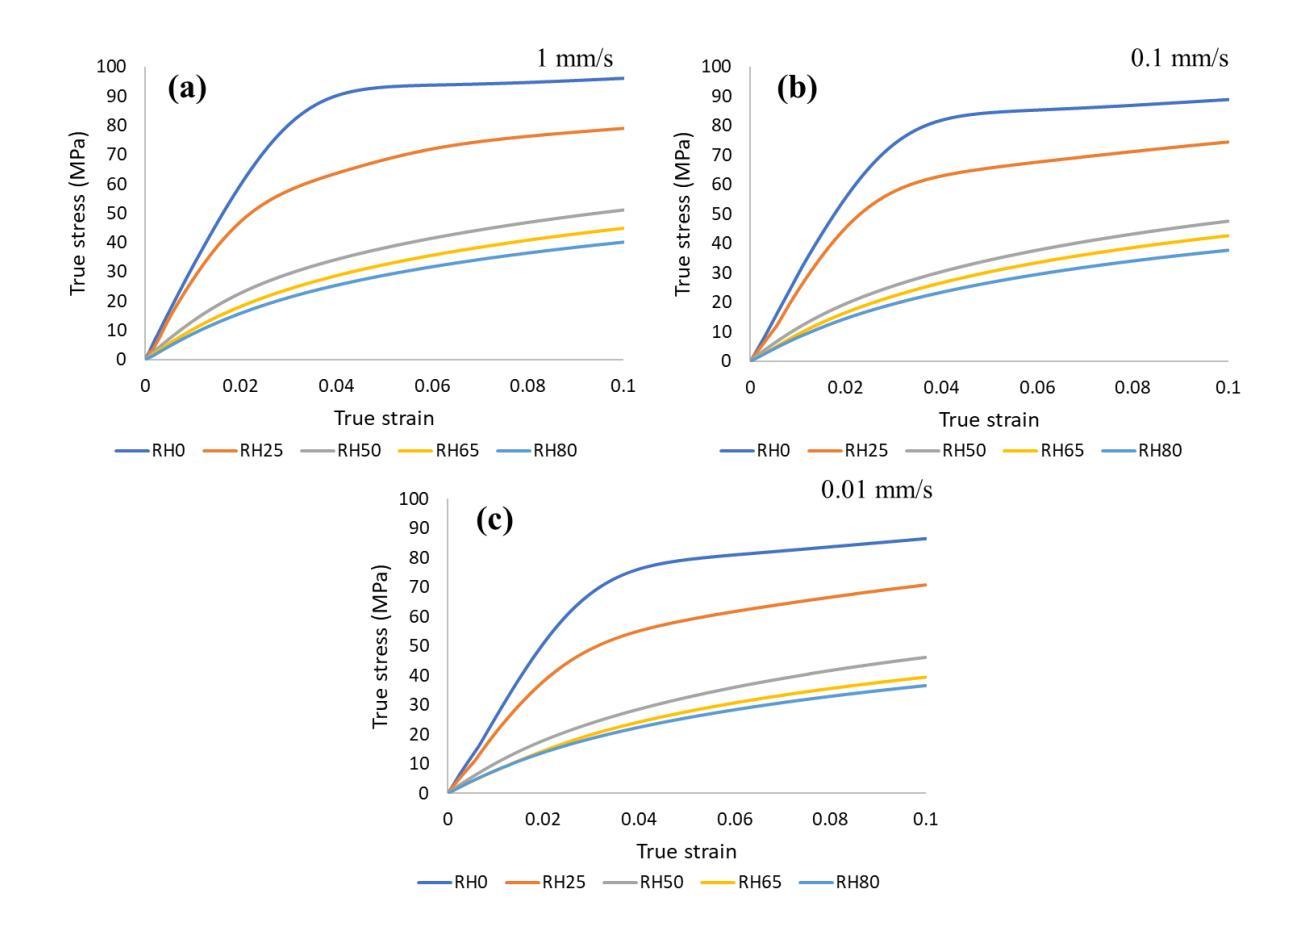
Figure 83. Monotonic tensile responses for PA66 conditioned at RH 0%, RH 25 %, RH 50%, RH 65% and RH 80%. (a) Crosshead displacement rate of 1 mm/s. (b) Crosshead displacement rate of 0.1 mm/s. (c) Crosshead displacement rate of 0.01 mm/s.

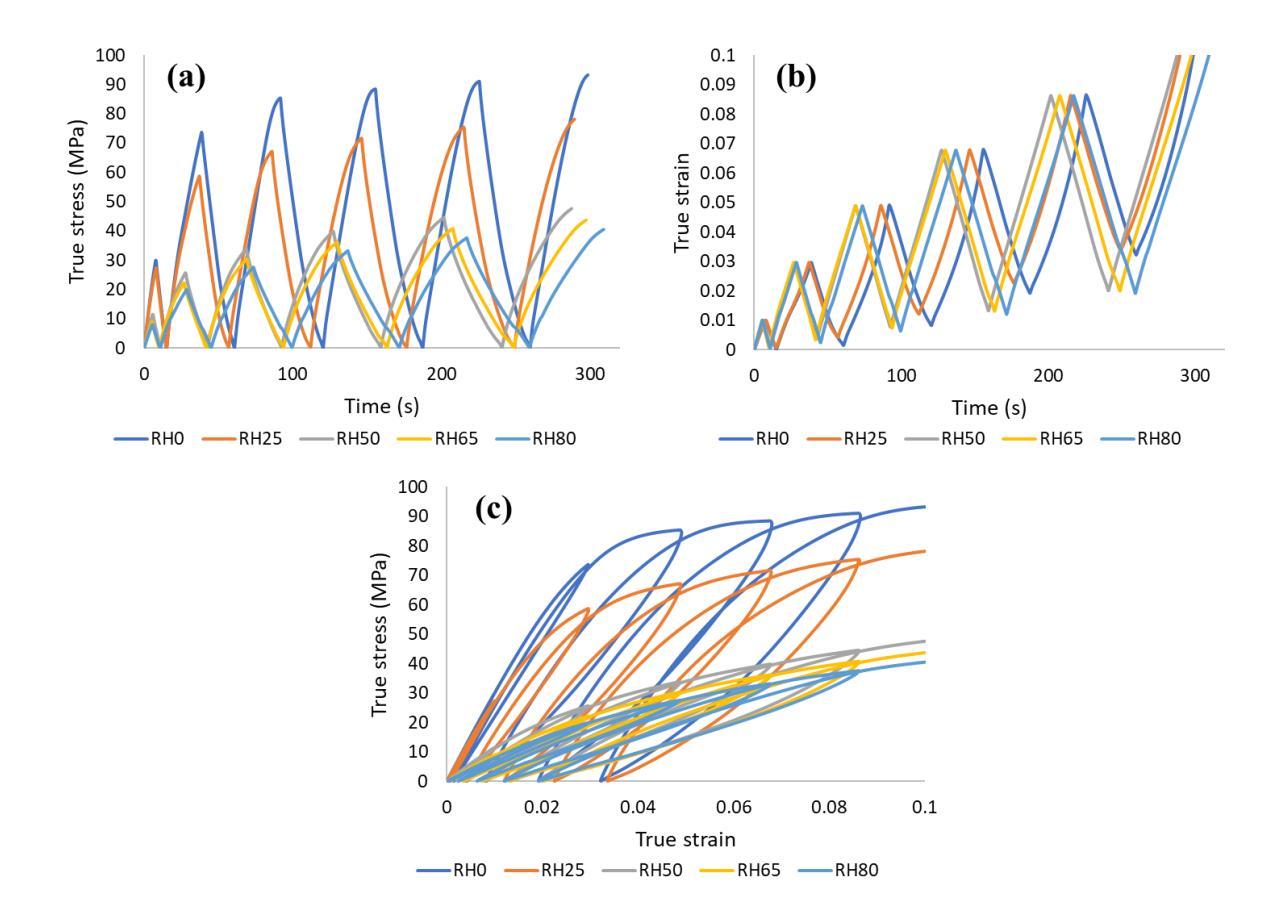
Figure 84. Load-unload responses for PA66 conditioned at RH 0%, RH 25 %, RH 50%, RH 65% and RH 80%, performed at 1 %, 3 %, 5 %, 7 %, 9 %, and 11 % strain levels, at 0.1 mm/s crosshead displacement rate. (a) True stress vs. Time. (b) True strain vs. Time. (c) True stress vs. True strain.

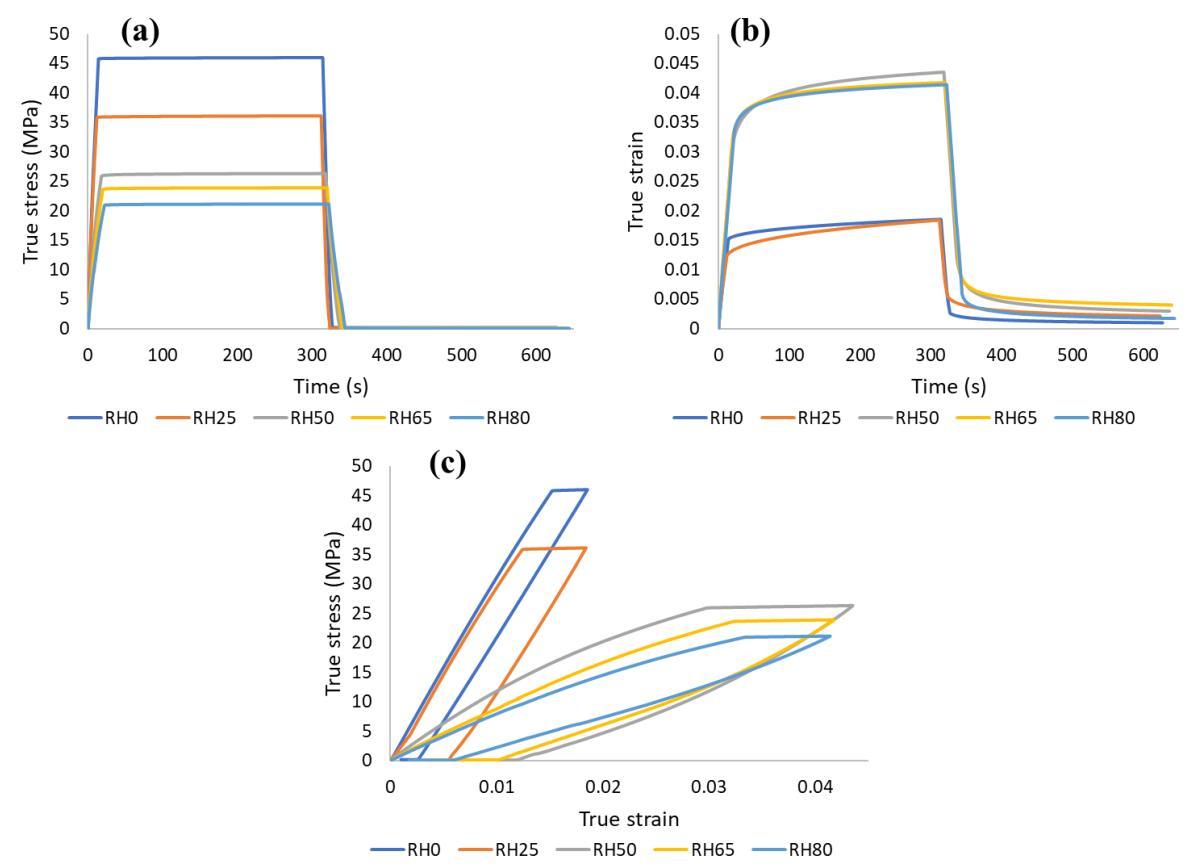
Figure 85. Creep-recovery responses at 50 % F_{max} for PA66 conditioned at RH 0%, RH 25 %, RH 50%, RH 65% and RH 80%. (a) True stress vs. Time. (b) True strain vs. Time. (c) True stress vs. True strain.

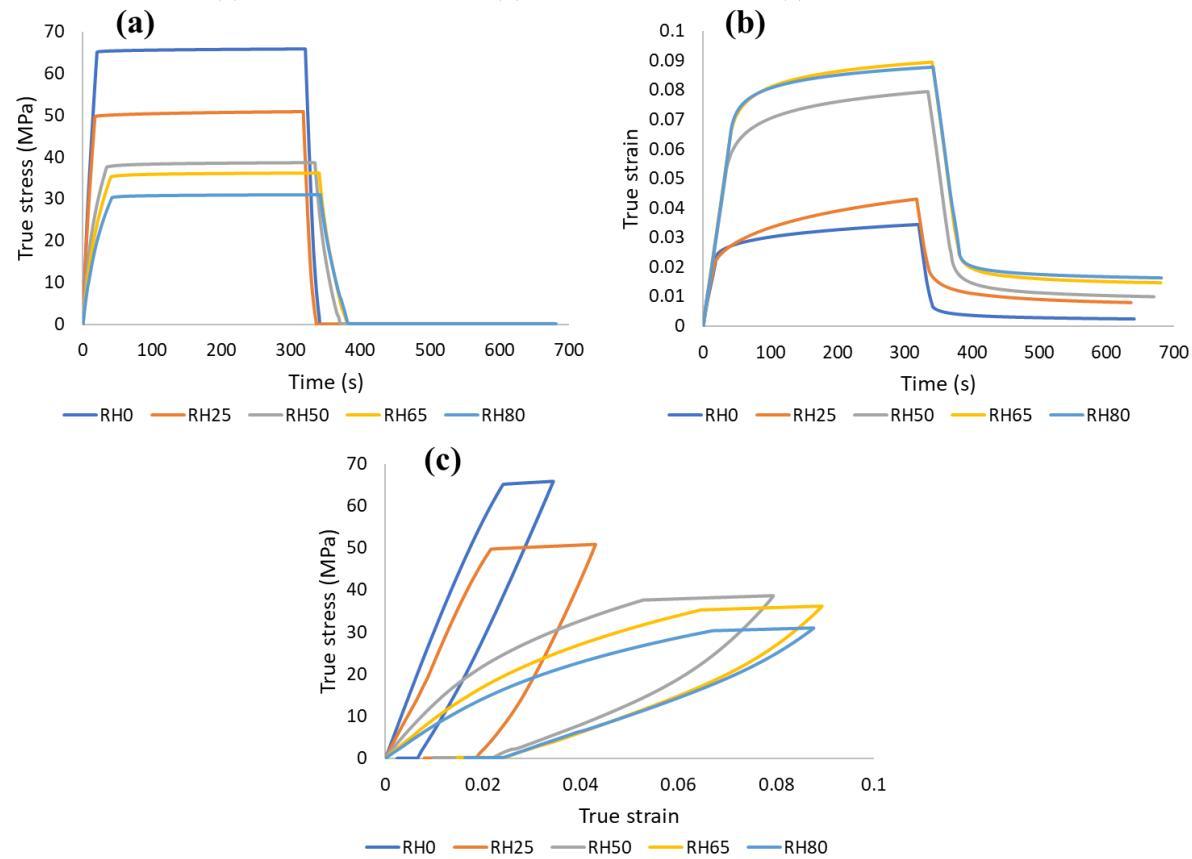
Figure 86. Creep-recovery responses at 70 % F_{max} for PA66 conditioned at RH 0%, RH 25 %, RH 50%, RH 65% and RH 80%. (a) True stress vs. Time. (b) True strain vs. Time. (c) True stress vs. True strain.
