Détection de l'endommagement dans un composite tissé PA66,6/Fibres de verre à l'aide de techniques ultrasonores en vue d'une prédiction de la durabilité de pièces automobiles

T H È S E

Damage detection in PA 66/6|Glass woven fabric composite material using ultrasonic techniques towards durability prediction of automotive parts

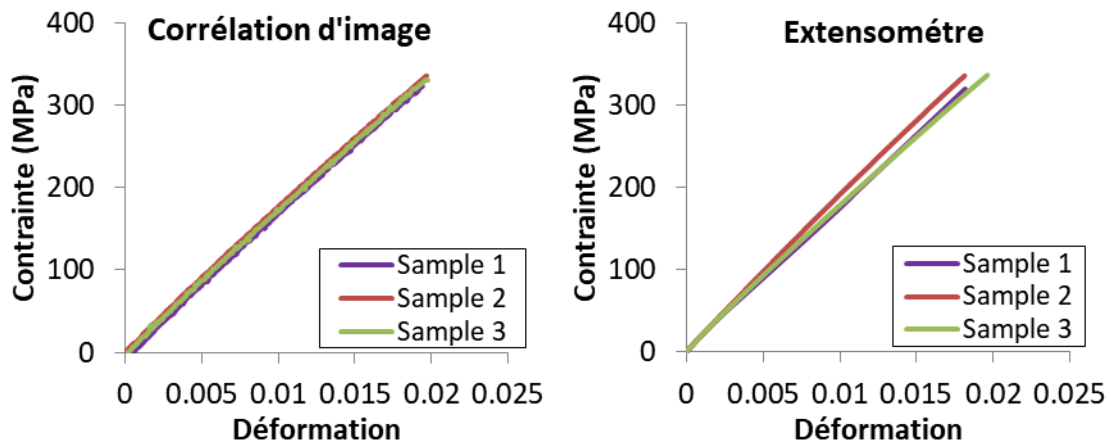
Figure 4 : Réponses contrainte/déformation obtenues par corrélation d'image (Gauche) et extensomètre (Droite) sur trois échantillons dans la configuration 0°.

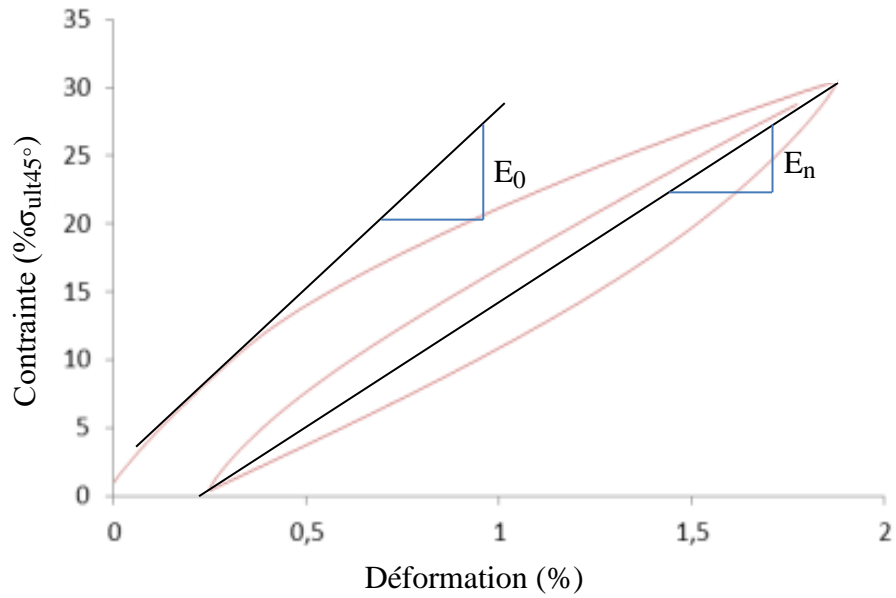
Figure 7 : Mesure des modules E_0 et E_n sur une courbe charge/décharge.

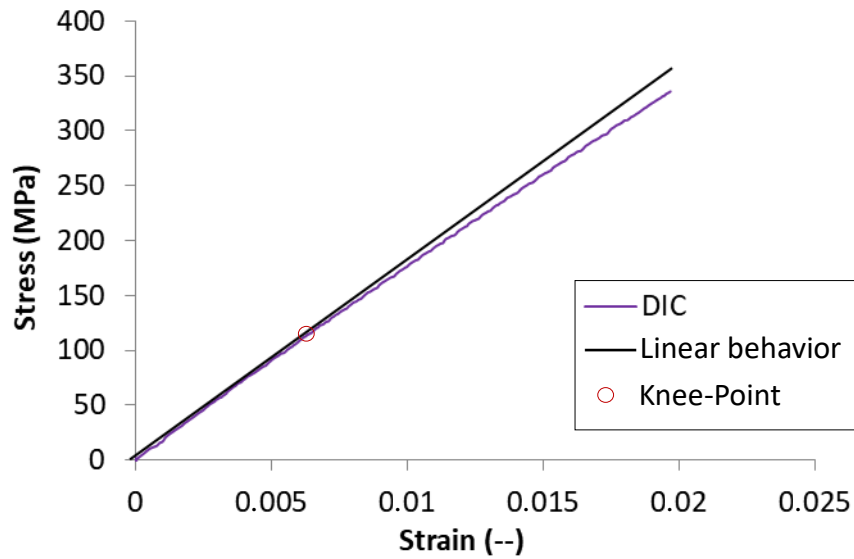
Figure 53 : Nonlinearity point on the stress-strain curve from DIC acquisitions

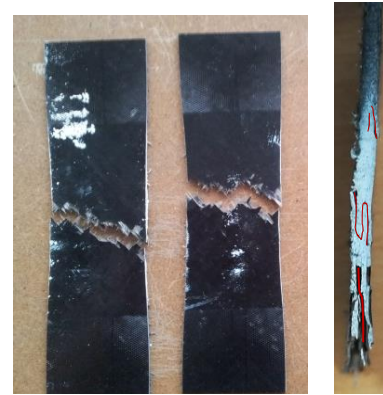
Figure 55 : 45° oriented sample

When the failure area visible in Figure 55 is observed, it can be noted that the crack is running at 45° of the loading direction, which is induced by the fabric orientation. The main crack is propagating in stairs shape; lots of delamination can be observed on the side of the sample relatively close to the failure zone.

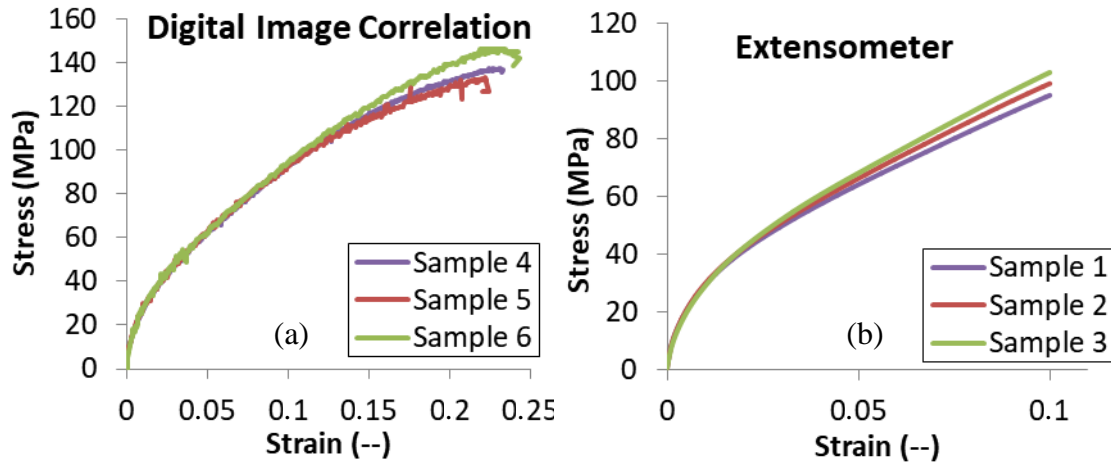
Figure 57 : Stress/Strain curve obtained with DIC (a) and Extensometer (b) for the three tested samples oriented at 45° from fiber's axis

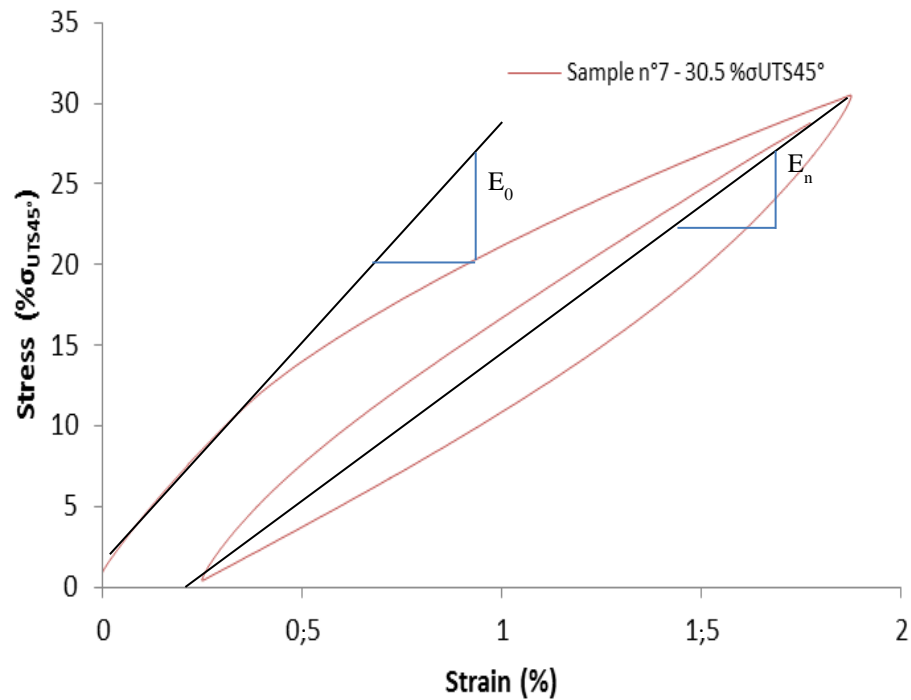
Figure 64 : Measurement of the E_0 and E_n moduli on a loading unloading curve

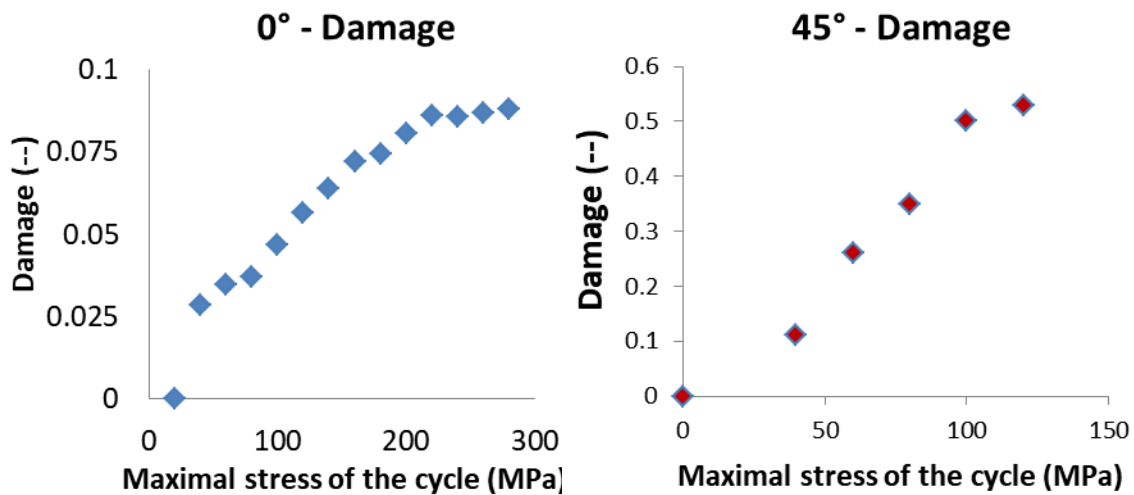
Figure 65 : Evolution of damage function of the maximal stress of the cycle for a 0° (Left) and 45° (Right) oriented sample

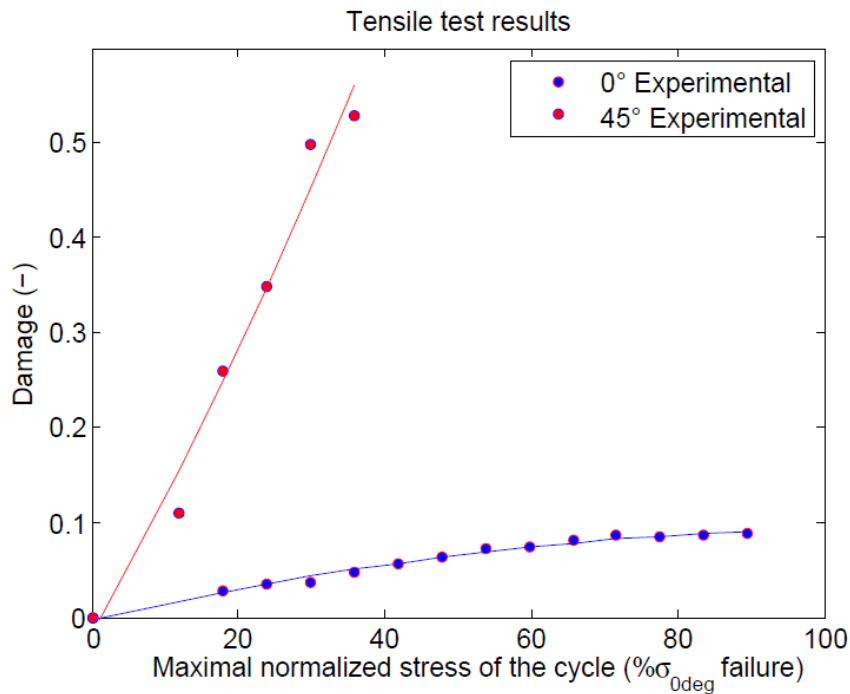
Figure 66 : Comparison of the Young modulus reduction during incremental cyclic test for 0° and 45° oriented samples

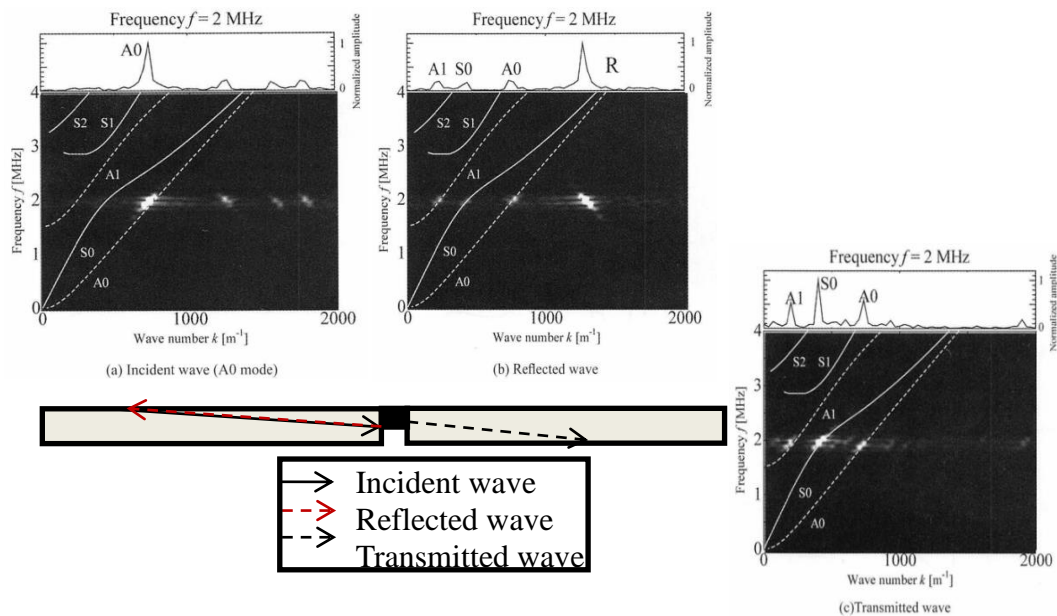
Figure 104 : Side observation of the sample + ultrasonic wave's propagation through the sample. 2D Fourier transform results for the incident, reflected and transmitted wave with the theoretical dispersion curves. (Based on [77])

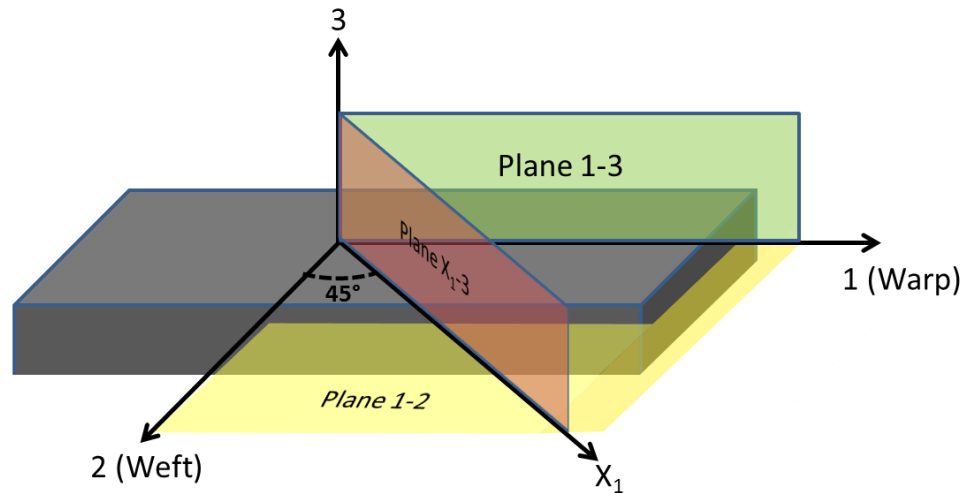
Figure 128 : Schematic representation of the different propagation planes of ultrasonic waves. For samples in the 0° configurations, the planes 1-3 and 1-2 were used. For the samples in the 45° configuration, the plane X_1 -3 and 1-2 were used.

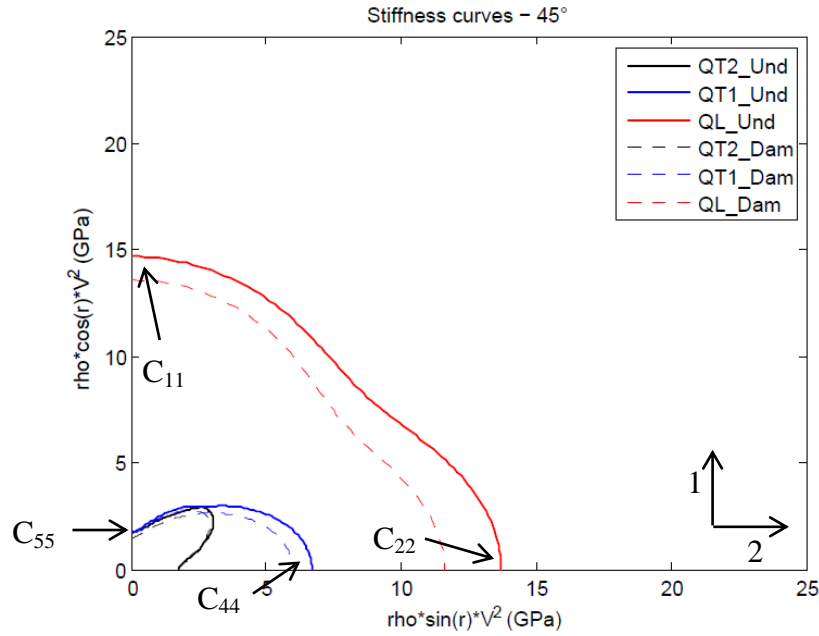
Figure 131 : Stiffness curves for two samples oriented at 45° from the fiber's axis. An undamaged sample and a sample loaded in tension at 120MPa

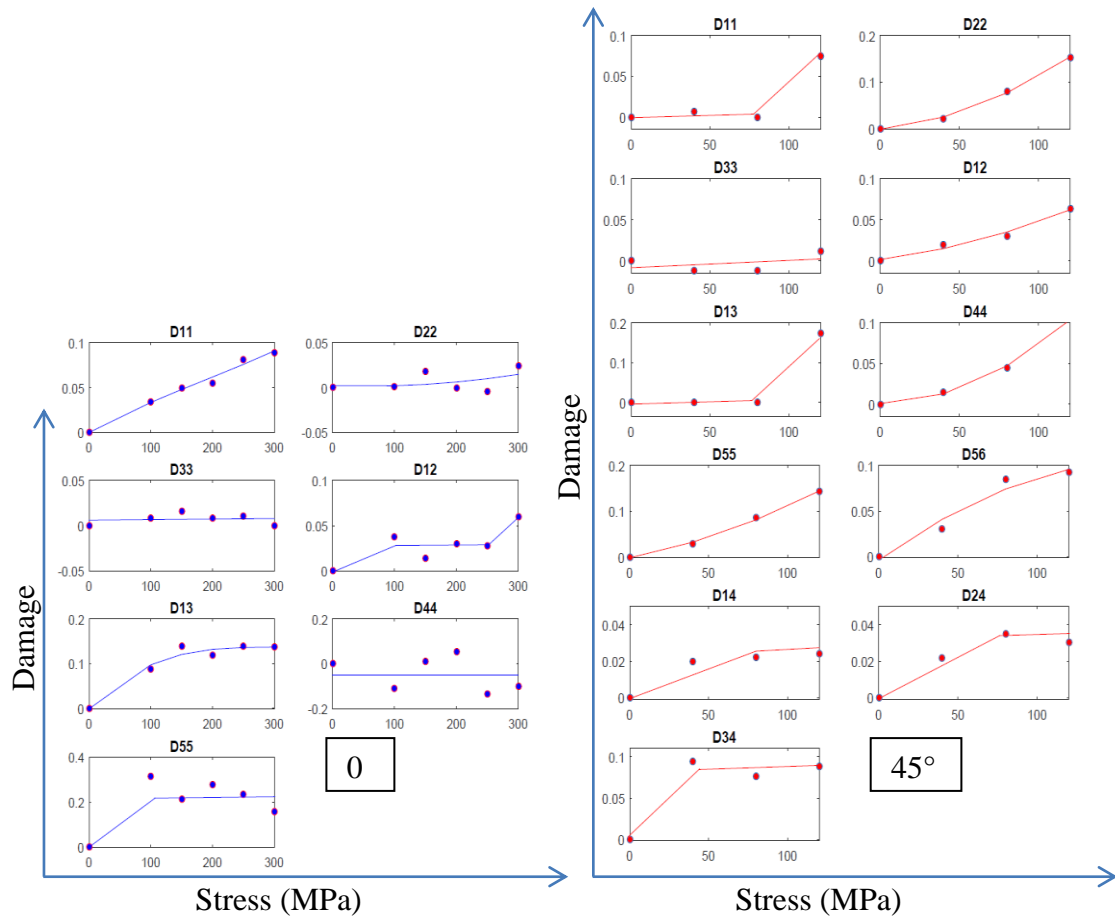
Figure 132 : Damage evolution with stress level of samples oriented at 0° and 45° obtained via ultrasonic measurements

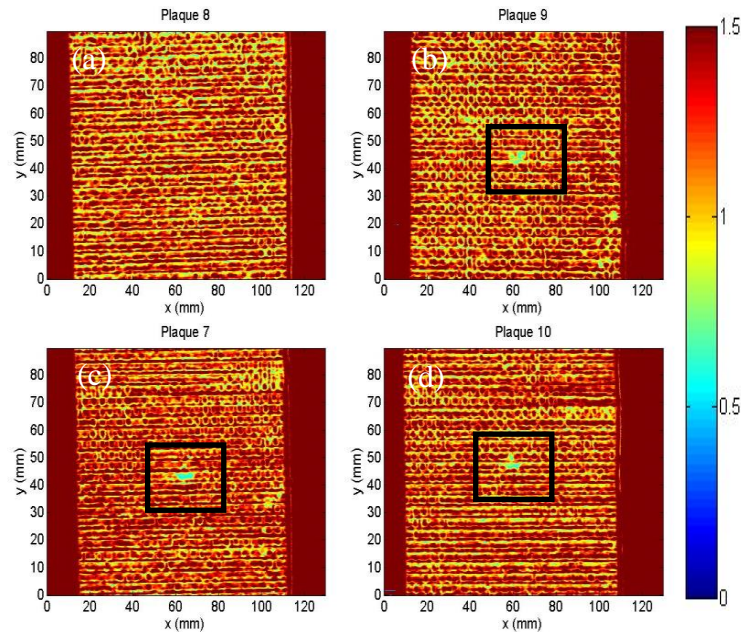
Figure 162 : Ultrasonic C-scan imaging in transmission with 10 MHz transducers for the plates impacted at an energy level of (a) 10, (b) 15, (c) 17.5 and (d) 20 J

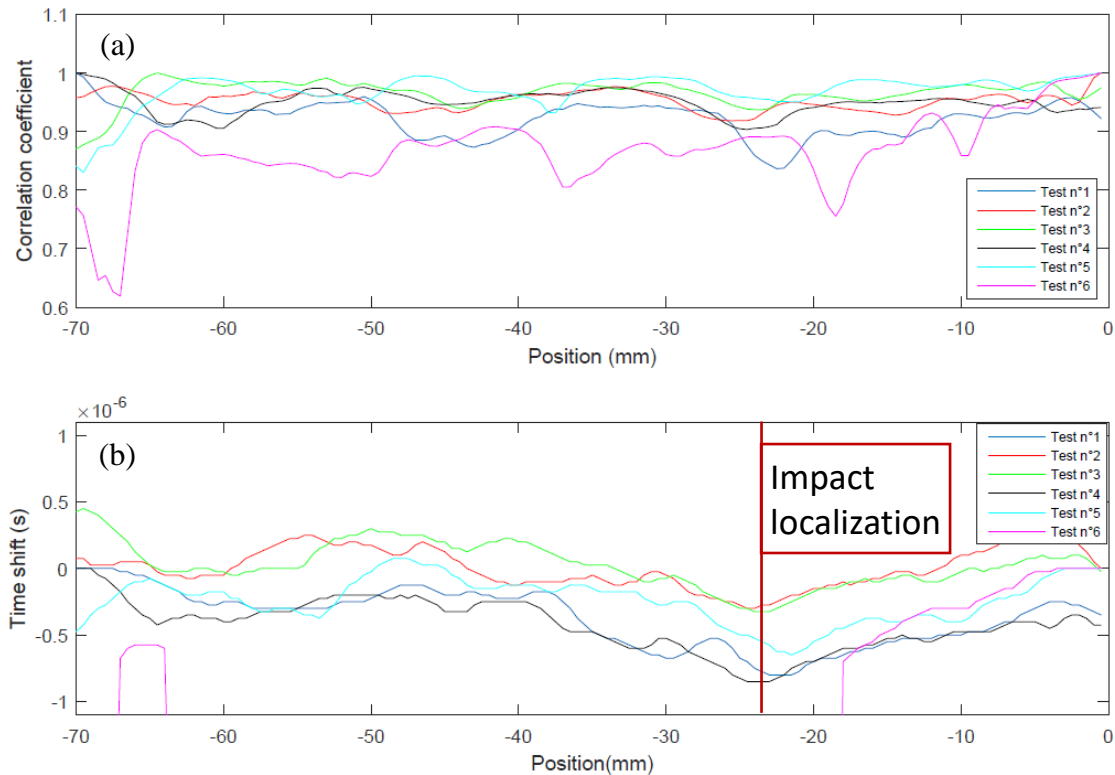
Figure 171 : (a) Evolution of the maximum correlation coefficient with the transducers position. (b) Evolution of the time lag with the transducers position

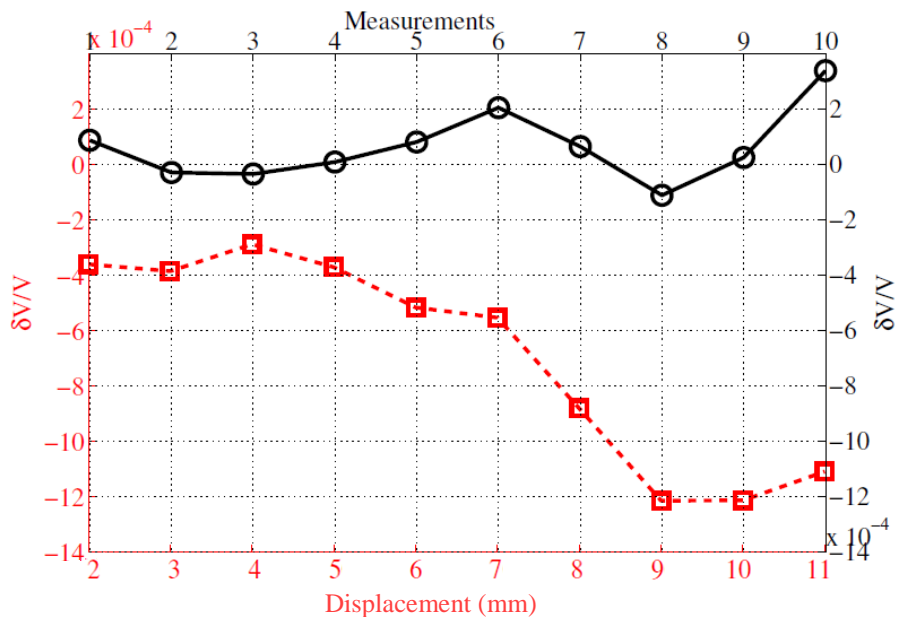
Figure 190 : Variation of $\delta V/V$ over the whole recorded signals for the sample 1 (in dashed red line) and the sample 2 (in continuous black line)
